DEPARTMENT OF TRANSPORTATION

Contract #: 04-0120F4Cty: SF/ALA Rte: 80 PM: 13.2/13.9File #: 69.28**WELDING INSPECTION REPORT****Resident Engineer:** Pursell, Gary**Address:** 333 Burma Road**City:** Oakland, CA 94607**Report No:** WIR-015445**Date Inspected:** 05-Jul-2010**Project Name:** SAS Superstructure**OSM Arrival Time:** 700**Prime Contractor:** American Bridge/Fluor Enterprises, a JV**OSM Departure Time:** 1900**Contractor:** Zhenhua Port Machinery Company, Ltd (ZPMC), Changxing Island **Location:** Shanghai, China**CWI Name:** Yang Bai Qiang**CWI Present:** Yes No**Inspected CWI report:** Yes No N/A**Rod Oven in Use:** Yes No N/A**Electrode to specification:** Yes No N/A**Weld Procedures Followed:** Yes No N/A**Qualified Welders:** Yes No N/A**Verified Joint Fit-up:** Yes No N/A**Approved Drawings:** Yes No N/A**Approved WPS:** Yes No N/A**Delayed / Cancelled:** Yes No N/A**Bridge No:** 34-0006**Component:** OBG**Summary of Items Observed:**

OBG Bay 04, Deck Panel 13CE-DP3101-001

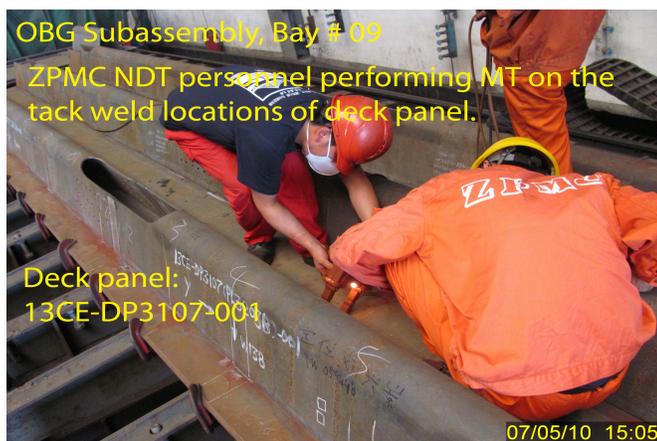
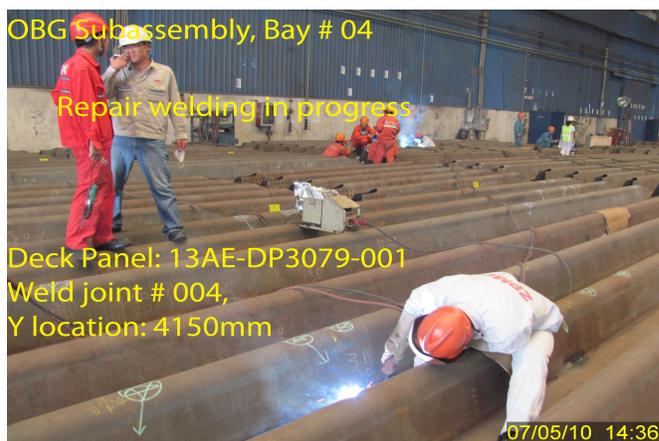
During random in process inspection this QA inspector observed that ZPMC personnel were performing repair welding (root pass) on the Partial Joint Penetration (PJP) weld joints of deck panel 13AE-DP3079-001. Welder is identified as 062265. ZPMC CWI is identified as Mr. Yang Bai Qiang. The welding variables recorded by QC appeared to comply with WPS-345-FCAW-2G(2F)-FCM-Repair. The repair area details are as follows.

During random in process inspection this QA inspector observed that ZPMC personnel were performing repair welding on the Partial Joint Penetration (PJP) weld joints of deck panel 13AW-DP3123-001. Welder is identified

as 068916. ZPMC CWI is identified as Mr. Yang Bai Qiang. The welding variables recorded by QC appeared to comply with WPS-345-FCAW-2G(2F)-FCM-Repair. The repair area details are as follows.
