**DEPARTMENT OF TRANSPORTATION**

Contract #: 04-0120F4Cty: SF/ALA Rte: 80 PM: 13.2/13.9File #: 69.28**WELDING INSPECTION REPORT****Resident Engineer:** Pursell, Gary**Address:** 333 Burma Road**City:** Oakland, CA 94607**Report No:** WIR-015541**Date Inspected:** 12-Jul-2010**Project Name:** SAS Superstructure**OSM Arrival Time:** 700**Prime Contractor:** American Bridge/Fluor Enterprises, a JV**OSM Departure Time:** 1900**Contractor:** Zhenhua Port Machinery Company, Ltd (ZPMC), Changxing Island **Location:** Shanghai, China**CWI Name:** Li Yang**CWI Present:** Yes No**Inspected CWI report:** Yes No N/A**Rod Oven in Use:** Yes No N/A**Electrode to specification:** Yes No N/A**Weld Procedures Followed:** Yes No N/A**Qualified Welders:** Yes No N/A**Verified Joint Fit-up:** Yes No N/A**Approved Drawings:** Yes No N/A**Approved WPS:** Yes No N/A**Delayed / Cancelled:** Yes No N/A**Bridge No:** 34-0006**Component:** OBG Segment**Summary of Items Observed:**

## WELDING INSPECTION REPORT

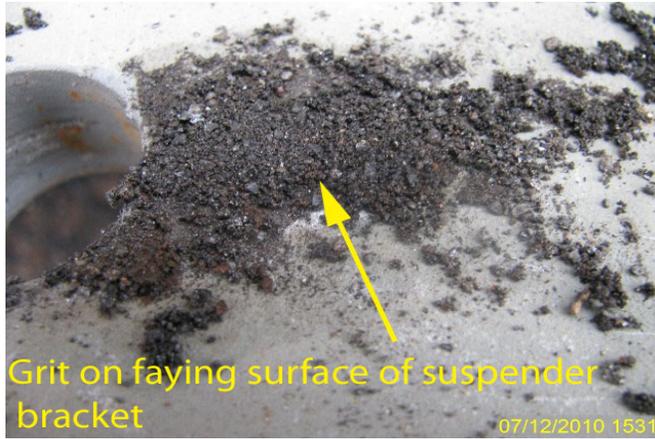
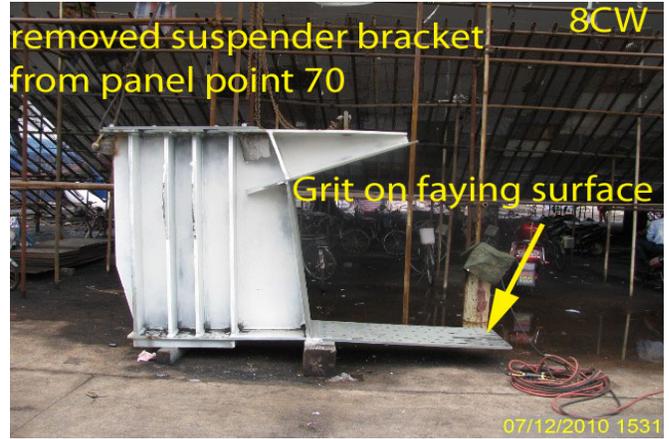
This QA Inspector observed Suspender Bracket at panel point 70 was removed due to blast grit in the faying surface of the Suspender Bracket and Side Plate connection. Pictures below show condition of suspender bracket after removal.
