DEPARTMENT OF TRANSPORTATION

Contract #: 04-0120F4Cty: SF/ALA Rte: 80 PM: 13.2/13.9File #: 1.28**WELDING INSPECTION REPORT****Resident Engineer:** Pursell, Gary**Address:** 333 Burma Road**City:** Oakland, CA 94607**Report No:** WIR-015542**Date Inspected:** 07-Jul-2010**Project Name:** SAS Superstructure**OSM Arrival Time:** 600**Prime Contractor:** American Bridge/Fluor Enterprises, a JV**OSM Departure Time:** 1500**Contractor:** American Bridge/Fluor Enterprises, a JV**Location:** Job Site

The Quality Assurance (QA) Inspector, Rick Bettencourt was on site at the job site between the times noted above. The QA Inspector was on site to randomly observe the in process welding and inspection of the weld joints identified 4E/5E, 5W/6W, 3E/4E, and the following observations were made:

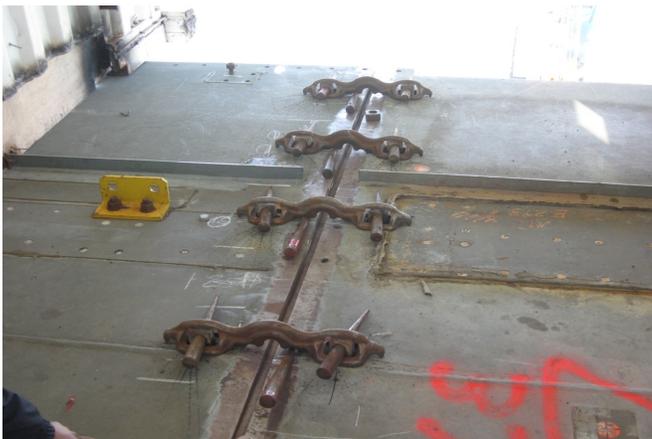
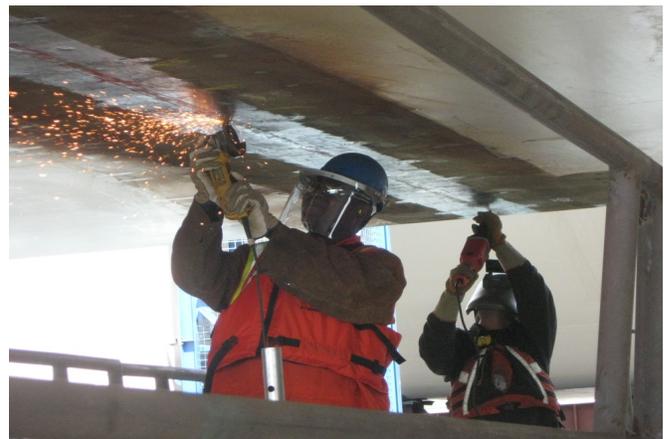
3E/4E-D

excavations and weld repairs from previously rejected and indicated weld defects. The QA Inspector randomly observed the SE QC Inspector Jesse Cayabyab was present at the time of the excavations. The QA Inspector randomly observed the ABF welder Fred Kaddu begin excavating the ultrasonic testing (UT) reject. The QA Inspector randomly observed the QC Inspector performed magnetic particle testing of the excavated area. The QA Inspector noted no relevant indications were located at the time of the testing. The QA Inspector noted the Y dimension of the excavation was Y=3325mm-3435mm. The QA Inspector noted the dimensions of the excavations were 110mm X 26mm X 15mm deep. The QA Inspector randomly observed the ABF welder begin welding the shielded metal arc welding (SMAW) repair of the excavation identified above. The QA Inspector randomly observed the ABF welder utilizing 1/8" E7018 Low Hydrogen electrodes with 128 Amps. The QA Inspector noted the SMAW parameters appeared to be in general compliance with ABF-WPS-D1.5-1000-Repair. The QA Inspector noted, once the repair was complete the ABF welder and helper went to the external surface of the transverse weld splice (pictured below). The QA Inspector noted the ABF welders continued to excavate the UT rejections.
