DEPARTMENT OF TRANSPORTATION

Contract #: 04-0120F4Cty: SF/ALA Rte: 80 PM: 13.2/13.9File #: 1.28**WELDING INSPECTION REPORT****Resident Engineer:** Pursell, Gary**Address:** 333 Burma Road**City:** Oakland, CA 94607**Report No:** WIR-015544**Date Inspected:** 08-Jul-2010**Project Name:** SAS Superstructure**OSM Arrival Time:** 630**Prime Contractor:** American Bridge/Fluor Enterprises, a JV**OSM Departure Time:** 1500**Contractor:** American Bridge/Fluor Enterprises, a JV**Location:** Job Site

5W/6W-A

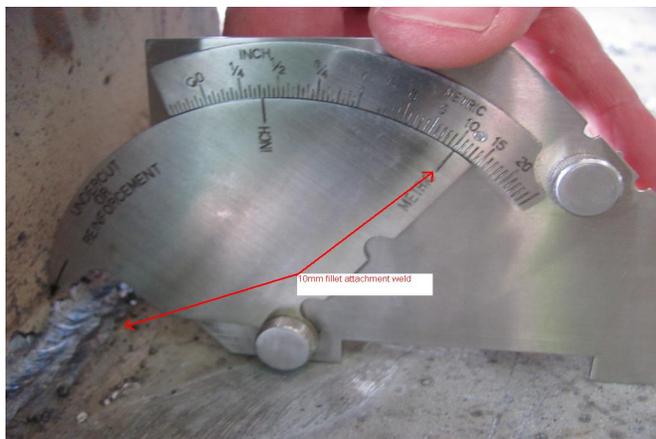
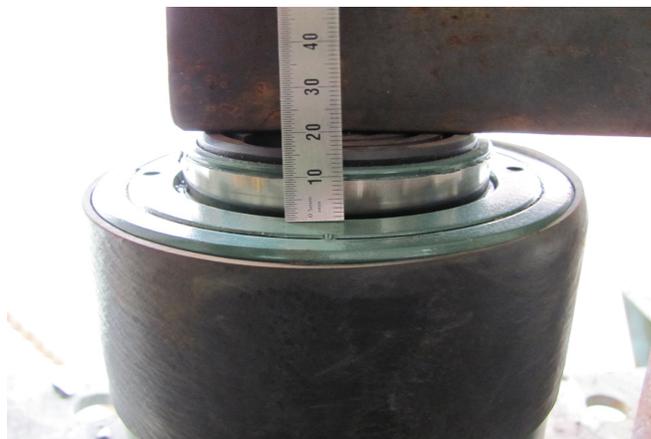
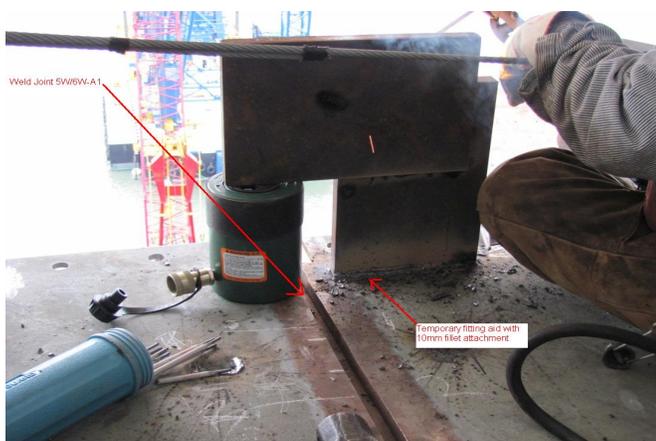
Upon the arrival of the QA Inspector in the am it was observed the above identified weld joint was fit up with the approved temporary attachments or fit up gear in place. The QA Inspector was informed by the SE QC Inspector the previous dimensional measurements had changed from the day prior (see summary of conversations). Upon the arrival of the QA Inspector, the QC and the QA Inspector performed dimensional measurements of the planar misalignment and noted a significant change from the previous day shift. The QA Inspector noted the only unacceptable planar misalignment in the entire weld joint was in weld segment A1. The QA Inspector measured approximately 250mm of planar misalignment beginning at A1 and spanning toward A2. The QA Inspector noted the misalignment was measured at 12mm. The ABF welder Rick Clayborn was on site to perform additional fitting tasks to correct the planar misalignment (see summary of conversation).

The QA Inspector randomly observed the ABF welder Rick Clayborn install a steel plate configuration in the shape of an “L” to create a leverage point for the 55 ton hydraulic jack (pictured below). The QA Inspector noted the jack would apply force to the 5W side of A1 to bring the member down to within the tolerances of AWS D1.5. The QA Inspector randomly observed the ABF welder utilize shielded metal arc welding (SMAW) with 1/8” E7018 low hydrogen electrodes and 133 Amps. The QA Inspector noted the area was preheated with a rose bud torch prior to welding. The QA Inspector randomly observed the ABF welder install the steel plate with a 10mm fillet weld on three sides of the attachment. The QA Inspector noted the weld size and quality was a direct non conformance of ABF-SUB-001361 Rev.01. The QA Inspector wrote and submitted an incident report for the above identified issue. After the temporary attachment was installed, the QA Inspector randomly observed the ABF welder install the 55 ton hydraulic jack and apply force until the two members were of zero planar misalignment. The QA Inspector noted the hydraulic jack did not have a pressure gauge, thus the QA Inspector was unable to determine the amount of force applied to the area. The QA Inspector did noted the ram appeared to be extended approximately 10mm (pictured below). The QA Inspector performed a dimensional verification of the area after the force was applied and noted the planar misalignment was zero. The QA Inspector noted the %w side of the weld joint moved approximately 11mm with the hydraulic force. The QA Inspector noted no additional welding was performed on the QA Inspectors shift.
