DEPARTMENT OF TRANSPORTATION

Contract #: 04-0120F4Cty: SF/ALA Rte: 80 PM: 13.2/13.9File #: 74.28**WELDING INSPECTION REPORT****Resident Engineer:** Pursell, Gary**Address:** 333 Burma Road**City:** Oakland, CA 94607**Report No:** WIR-015550**Date Inspected:** 25-Jun-2010**Project Name:** SAS Superstructure**Prime Contractor:** American Bridge/Fluor Enterprises, a JV**Contractor:** Goodwin Steel, UK**OSM Arrival Time:** 745**OSM Departure Time:** 1700**Location:** Trentham, UK**CWI Name:****CWI Present:**

Bridge No: 34-0006**Component:** Cable Band**Summary of Items Observed:**

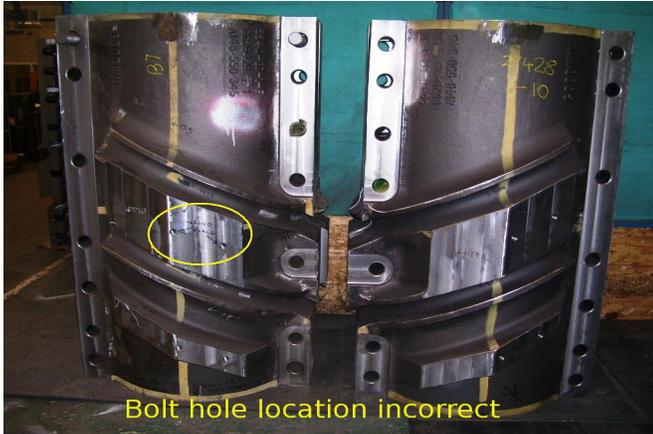
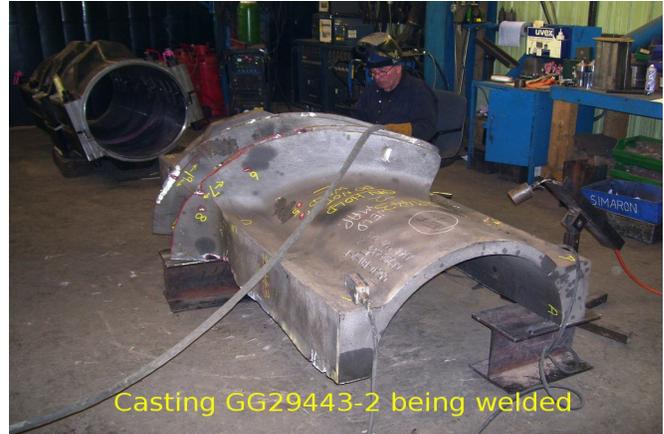
The bolt holes in the stanchion pads for casting GG429-1, 5540-B7-1-F appears to have been drilled in the wrong location.
