DEPARTMENT OF TRANSPORTATION

Contract #: 04-0120F4Cty: SF/ALA Rte: 80 PM: 13.2/13.9File #: 69.28**WELDING INSPECTION REPORT****Resident Engineer:** Pursell, Gary**Address:** 333 Burma Road**City:** Oakland, CA 94607**Report No:** WIR-015573**Date Inspected:** 10-Jul-2010**Project Name:** SAS Superstructure**OSM Arrival Time:** 700**Prime Contractor:** American Bridge/Fluor Enterprises, a JV**OSM Departure Time:** 1900**Contractor:** Zhenhua Port Machinery Company, Ltd (ZPMC), Changxing Island **Location:** Shanghai, China**CWI Name:** Mr. Huang min**CWI Present:** Yes No**Inspected CWI report:** Yes No N/A**Rod Oven in Use:** Yes No N/A**Electrode to specification:** Yes No N/A**Weld Procedures Followed:** Yes No N/A**Qualified Welders:** Yes No N/A**Verified Joint Fit-up:** Yes No N/A**Approved Drawings:** Yes No N/A**Approved WPS:** Yes No N/A**Delayed / Cancelled:** Yes No N/A**Bridge No:** 34-0006**Component:** Orthotropic Box Girder (OBG)**Summary of Items Observed:**

WELDING INSPECTION REPORT

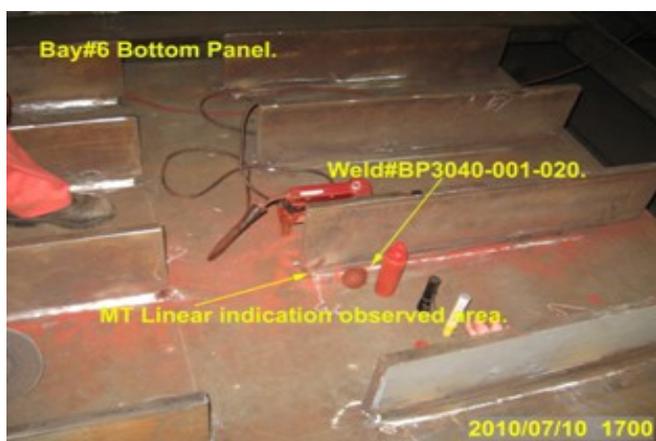
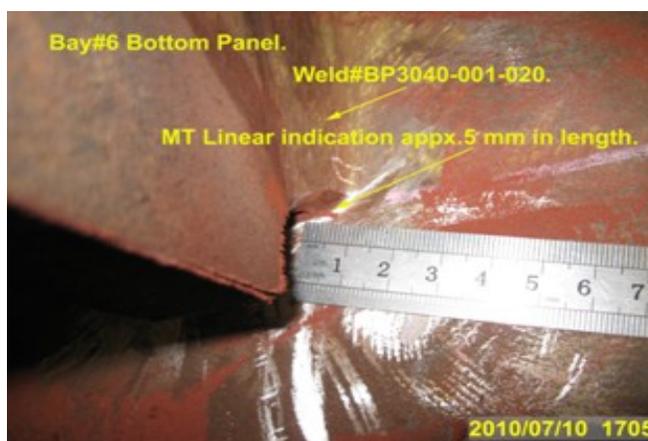
During Quality Assurance Magnetic Particle Testing (MT) review of welds located on OBG Bottom Panel (BP) BP3040A, this QA observed One (1) longitudinal surface linear indication measuring approximately 5 mm in length. The weld is identified as: BP3040-001-020. The weld is a fillet weld joining Bottom plate to Stiffener plate. The fillet weld size measured to be 9 mm. The "Y" location is 0 from the nearest end of the weld. The indication is located within the area that has been previously tested and accepted by ZPMC Quality Control (QC) personnel. As per the contract documents, ZPMC QC personnel are required to perform 10% MT inspection of these welds. This QA informed to ZPMC QC identified as Mr. Huang min and American Bridge/Fluor QA Inspector identified as Mr. Liu Hua Jie. This indication has been ground out and MT re tested found to be acceptable. Refer attached photos for more details.
