DEPARTMENT OF TRANSPORTATION

Contract #: 04-0120F4Cty: SF/ALA Rte: 80 PM: 13.2/13.9File #: 99.28**WELDING INSPECTION REPORT****Resident Engineer:** Pursell, Gary**Address:** 333 Burma Road**City:** Oakland, CA 94607**Report No:** WIR-015586**Date Inspected:** 09-Jul-2010**Project Name:** SAS Superstructure**OSM Arrival Time:** 700**Prime Contractor:** American Bridge/Fluor Enterprises, a JV**OSM Departure Time:** 1900**Contractor:** Zhenhua Port Machinery Company, Ltd (ZPMC) Chanxing Island **Location:** Shanghai, China

CWI Name:	N/A	CWI Present:	Yes	No
Inspected CWI report:	Yes No N/A	Rod Oven in Use:	Yes No N/A	
Electrode to specification:	Yes No N/A	Weld Procedures Followed:	Yes No N/A	
Qualified Welders:	Yes No N/A	Verified Joint Fit-up:	Yes No N/A	
Approved Drawings:	Yes No N/A	Approved WPS:	Yes No N/A	
		Delayed / Cancelled:	Yes No N/A	
Bridge No:	34-0006	Component:	OBG Segment 11BW

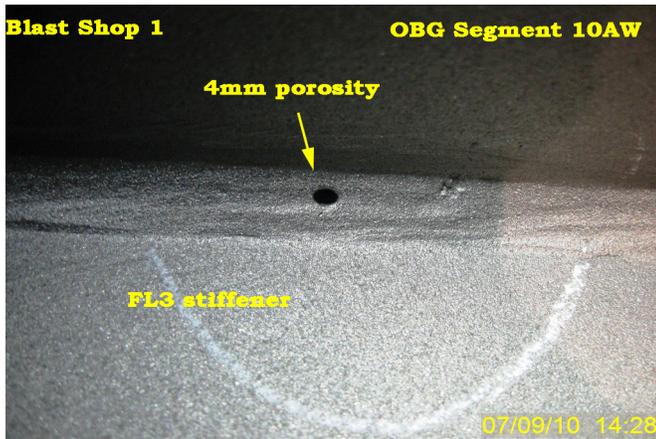
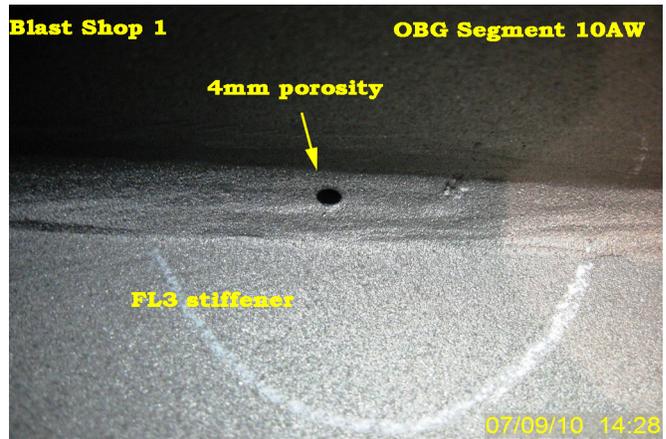
This QA Inspector performed a preliminary random visual inspection after the grit blast of the exterior components of the deck panel, floor beams and corner assemblies of this segment. Areas of visual weld defects that will require welding were taped and will be repaired after the coating is applied. ZPMC QC personnel are aware of these areas and were present during the inspection. See the attached picture.

Visual Inspection Details: During random Quality Assurance Visual review of welds located on segment 11BW, this Quality Assurance Inspector (QA) discovered no welding measuring approximately 15mm, in length. The unwelded area is clearly marked on the material near the weld. The weld is identified as SEG067A-037. The panel point is identified as a PP98. This weld is a Fillet weld joining the Floor beam Edge Plate. The Floor Beam Flange weld is identified as SPCM. For further information, please see the attached pictures
