DEPARTMENT OF TRANSPORTATION

Contract #: 04-0120F4Cty: SF/ALA Rte: 80 PM: 13.2/13.9File #: 1.28**WELDING INSPECTION REPORT****Resident Engineer:** Pursell, Gary**Address:** 333 Burma Road**City:** Oakland, CA 94607**Report No:** WIR-015590**Date Inspected:** 12-Jul-2010**Project Name:** SAS Superstructure**OSM Arrival Time:** 1000**Prime Contractor:** American Bridge/Fluor Enterprises, a JV**OSM Departure Time:** 1830**Contractor:** American Bridge/Fluor Enterprises, a JV**Location:** Job Site

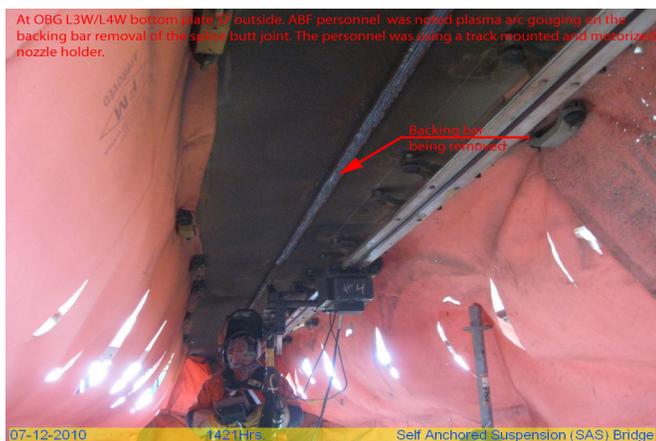
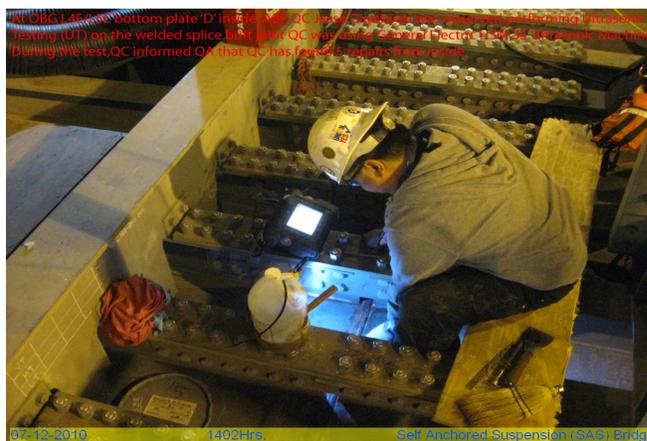
At OBG L3E/L4E bottom plate 'D' inside, QA randomly observed ABF/JV qualified welder Fred Kaddu continuing to perform CJP groove welding repair. The welder was observed welding in the 1G (flat) position utilizing Shielded metal Arc Welding (SMAW) with 1/8" diameter E7018H4R electrode implementing welding procedure ABF-WPS-D15-1000-Repairs. The weld repair was excavated to a boat shape. The repair excavation was preheated to more than 140 degree Fahrenheit using propane gas torch prior welding. During the shift, ABF QC William Sherwood was noted monitoring the welder. Prior welding, ABF QC William Sherwood was also observed performing Magnetic Particle Testing (MT) on the repair excavation. During the shift, the welder has completed one welding repair inside and has moved to OBG L4E/L5E bottom plate 'D' inside to perform more welding repairs. The welder was noted excavating the repair inside and has not performed any welding until the end of the shift.
