DEPARTMENT OF TRANSPORTATION

Contract #: 04-0120F4Cty: SF/ALA Rte: 80 PM: 13.2/13.9File #: 69.28**WELDING INSPECTION REPORT****Resident Engineer:** Pursell, Gary**Address:** 333 Burma Road**City:** Oakland, CA 94607**Report No:** WIR-015593**Date Inspected:** 10-Jul-2010**Project Name:** SAS Superstructure**OSM Arrival Time:** 645**Prime Contractor:** American Bridge/Fluor Enterprises, a JV**OSM Departure Time:** 1845**Contractor:** Zhenhua Port Machinery Company, Ltd (ZPMC), Changxing Island **Location:** Shanghai, China**CWI Name:** Chen Shi Gang.**CWI Present:** Yes No**Inspected CWI report:** Yes No N/A**Rod Oven in Use:** Yes No N/A**Electrode to specification:** Yes No N/A**Weld Procedures Followed:** Yes No N/A**Qualified Welders:** Yes No N/A**Verified Joint Fit-up:** Yes No N/A**Approved Drawings:** Yes No N/A**Approved WPS:** Yes No N/A**Delayed / Cancelled:** Yes No N/A**Bridge No:** 34-0006**Component:** Orthotropic Box Girder (OBG)**Summary of Items Observed:**

Subassembly, Bay 09, Gantry# 2, 13CE, Deck Plate to U-rib.

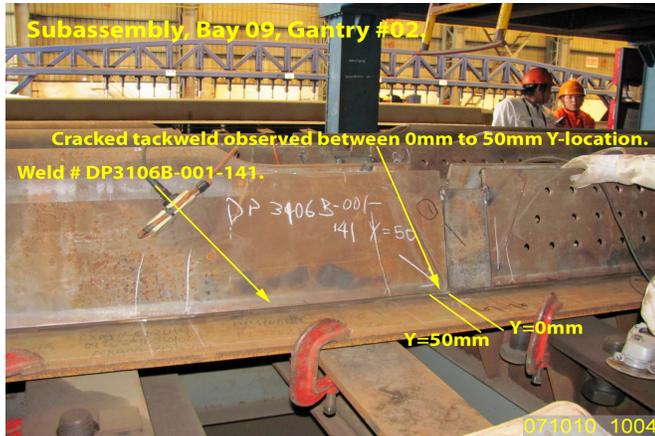
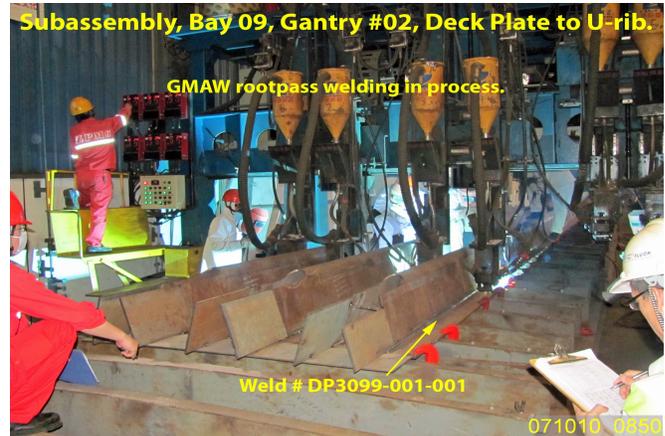
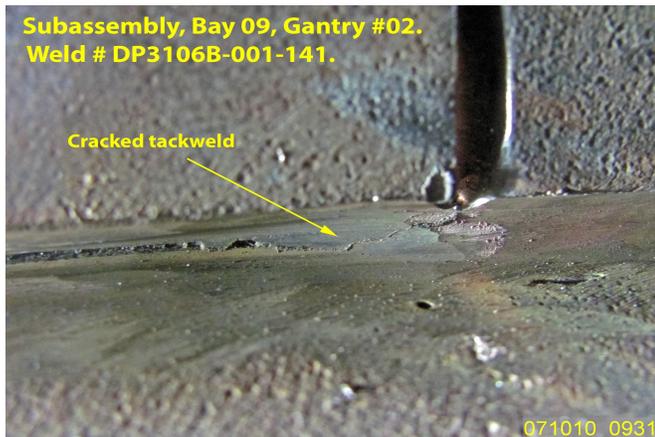
Before welding above panel; During random Visual testing this QA inspector observed Cracked Tack weld between Y-location 0mm & 50mm. Weld was identified as DP3106B-001-141. ZPMC marked this location & ZPMC NDT personnel “Wang Wei” carried out Magnetic Particle Testing (MT) at all similar locations on the above mentioned deck panel. On the completion of NDT, ZPMC continued the production. Attached photographs provide additional detail.

This QA inspector informed ZPMC QC “Duan Ya Bing” about cracked tack weld (Time: 0930). ZPMC NDT personnel Completed MT on all similar locations. (Time: 1045). ZPMC Started production (Time: 1400).
