DEPARTMENT OF TRANSPORTATION

Quality Assurance and Source Inspection

Contract #: 04-0120F4Cty: SF/ALA Rte: 80 PM: 13.2/13.9File #: 69.28**WELDING INSPECTION REPORT****Resident Engineer:** Pursell, Gary**Address:** 333 Burma Road**City:** Oakland, CA 94607**Report No:** WIR-015622**Date Inspected:** 14-Jul-2010**Project Name:** SAS Superstructure**OSM Arrival Time:** 700**Prime Contractor:** American Bridge/Fluor Enterprises, a JV**OSM Departure Time:** 1900**Contractor:** Zhenhua Port Machinery Company, Ltd (ZPMC), Changxing Island **Location:** Shanghai, China**CWI Name:** Xu Tao**CWI Present:** Yes No**Inspected CWI report:** Yes No N/A**Rod Oven in Use:** Yes No N/A**Electrode to specification:** Yes No N/A**Weld Procedures Followed:** Yes No N/A**Qualified Welders:** Yes No N/A**Verified Joint Fit-up:** Yes No N/A**Approved Drawings:** Yes No N/A**Approved WPS:** Yes No N/A**Delayed / Cancelled:** Yes No N/A**Bridge No:** 34-0006**Component:** OBG Components**Summary of Items Observed:**

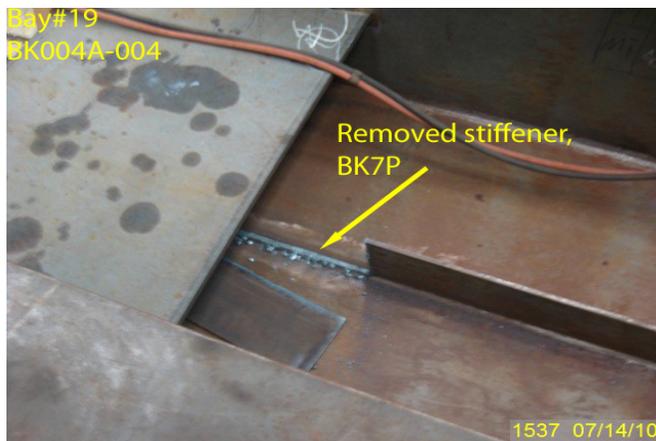
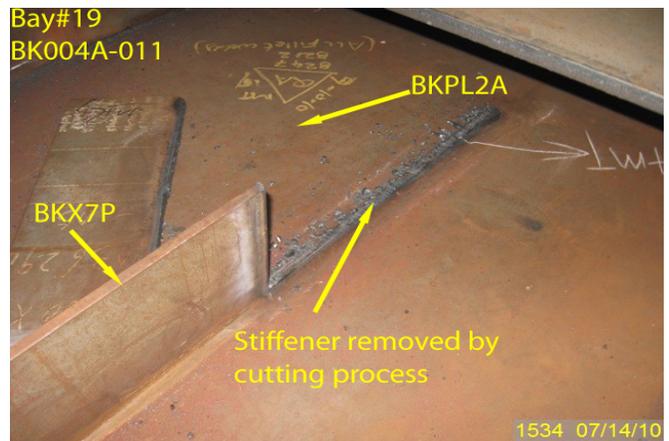
During random visual inspection of the Bike path BK 004A-008, BK004A-010 and BK004A-011, this QA inspector observed ZPMC personnel perform flame cutting on internal BKX7P stiffeners. The BKX7P stiffeners was welded (Fillet) to the top plate of the bike path. Required NDT work was performed and accepted by ZPMC and CT on these welds.

According to RFI 1690-R4, the interior end diaphragm plate will be welded with stringer plates. The BKX7P stiffener creates an obstacle during the fit up of end diaphragm plate. The cutting was performed, approximately 1200mm on both the ends. ZPMC personnel have required grinding flush the cutting area and performing NDT inspection. According to approved drawing this weld is not fracture critical weld. For further information, please see attached pictures.
