Contract #: 04-0120F4Cty: SF/ALA Rte: 80 PM: 13.2/13.9File #: 1.28**WELDING INSPECTION REPORT****Resident Engineer:** Pursell, Gary**Address:** 333 Burma Road**City:** Oakland, CA 94607**Report No:** WIR-015644**Date Inspected:** 12-Jul-2010**Project Name:** SAS Superstructure**OSM Arrival Time:** 630**Prime Contractor:** American Bridge/Fluor Enterprises, a JV**OSM Departure Time:** 1500**Contractor:** American Bridge/Fluor Enterprises, a JV**Location:** Job Site

The Quality Assurance (QA) Inspector, Rick Bettencourt was on site at the job site between the times noted above. The QA Inspector was on site to randomly observe the in process welding and inspection of the weld joints identified 5W/6W, and the following observations were made:

5W/6W-A

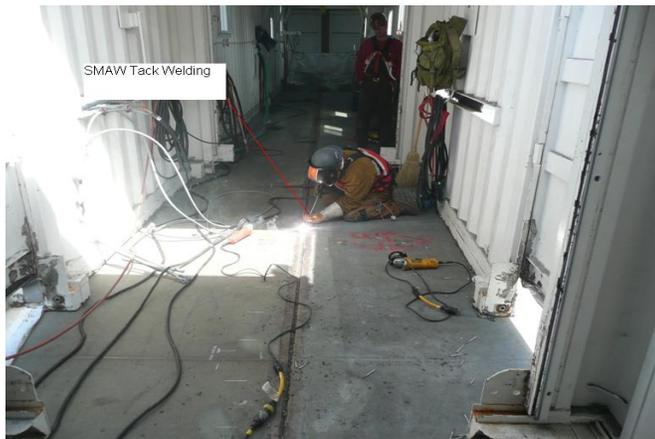
Upon the arrival of the QA Inspector in the am it was observed the above identified weld joint was fit up with the approved temporary attachments or fit up gear in place. The QA Inspector performed dimensional measurements of the fit up of the two top deck plate members. The QA Inspector noted prior to any weld being deposited in the weld joint, the above identified weld joint was found to have zero planar misalignment. Upon the arrival of the QA Inspector in the am the flowing locations were found to have planar misalignment. It was noted the dimensional measurements were taken at 0800 while the steel was 58°F:

- 1.) Y=0mm-80mm (8mm-2mm) A1
- 2.) Y=2025mm-2055mm (3mm-3.5mm)A1
- 3.) Y=8890mm-8950mm (3mm) A2
- 4.) Y=22870mm-23135mm (3mm) A5
- 5.) Y=23460mm-23650mm (3.5mm) A5

by welding. The QA Inspector noted the full length tack welds appeared to approximately 60% complete upon the arrival of the QA Inspector in the am. The QA Inspector noted the all of the weld segment A1 and approximately at the 6800mm mark in weld segment A2 was tack welded with flux cored arc welding (FCAW). The QA Inspector noted the all of the weld segment A5 and approximately at the 20000mm mark in weld segment A4 was tack welded with flux cored arc welding (FCAW). The QA Inspector noted the entire remaining weld joint was welded with shielded metal arc welding (SMAW). The QA Inspector noted the ABF welder James Zhen was performing SMAW in the center of the weld joint. The QA Inspector repeated the dimensional measurements of the same areas previously measured and noted the time and temperature were 1130 and the steel was 63°F. The QA Inspector noted there was no change from the dimensional measurements taken above.
