**DEPARTMENT OF TRANSPORTATION**

Quality Assurance and Source Inspection

Contract #: 04-0120F4Cty: SF/ALA Rte: 80 PM: 13.2/13.9File #: 69.28**WELDING INSPECTION REPORT****Resident Engineer:** Pursell, Gary**Address:** 333 Burma Road**City:** Oakland, CA 94607**Report No:** WIR-015653**Date Inspected:** 17-Jul-2010**Project Name:** SAS Superstructure**OSM Arrival Time:** 700**Prime Contractor:** American Bridge/Fluor Enterprises, a JV**OSM Departure Time:** 1900**Contractor:** Zhenhua Port Machinery Company, Ltd (ZPMC), Changxing Island **Location:** Shanghai, China**CWI Name:** Li Yang**CWI Present:** Yes No**Inspected CWI report:** Yes No N/A**Rod Oven in Use:** Yes No N/A**Electrode to specification:** Yes No N/A**Weld Procedures Followed:** Yes No N/A**Qualified Welders:** Yes No N/A**Verified Joint Fit-up:** Yes No N/A**Approved Drawings:** Yes No N/A**Approved WPS:** Yes No N/A**Delayed / Cancelled:** Yes No N/A**Bridge No:** 34-0006**Component:** OBG Segment**Summary of Items Observed:**

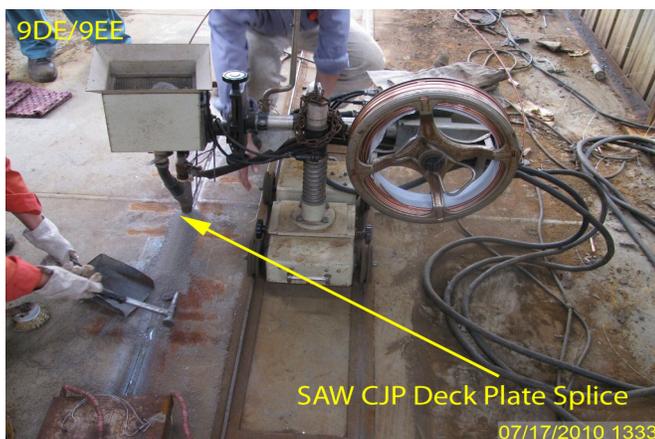
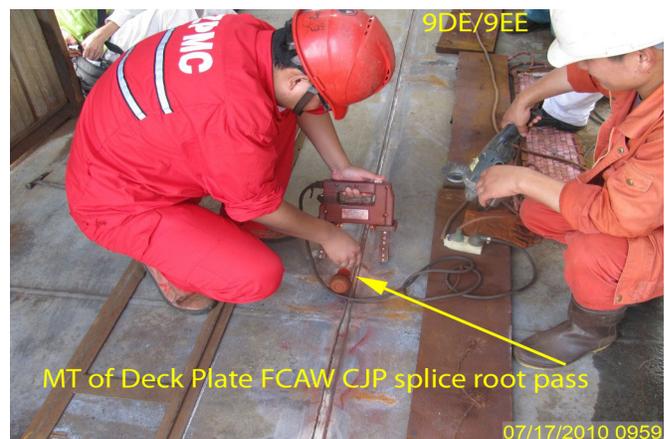
Unless otherwise noted, all work observed on this date appeared to generally comply with applicable contract documents.
