DEPARTMENT OF TRANSPORTATION

Quality Assurance and Source Inspection

Contract #: 04-0120F4Cty: SF/ALA Rte: 80 PM: 13.2/13.9File #: 69.28**WELDING INSPECTION REPORT****Resident Engineer:** Pursell, Gary**Address:** 333 Burma Road**City:** Oakland, CA 94607**Report No:** WIR-015700**Date Inspected:** 20-Jul-2010**Project Name:** SAS Superstructure**OSM Arrival Time:** 700**Prime Contractor:** American Bridge/Fluor Enterprises, a JV**OSM Departure Time:** 1900**Contractor:** Zhenhua Port Machinery Company, Ltd (ZPMC), Changxing Island **Location:** Shanghai, China

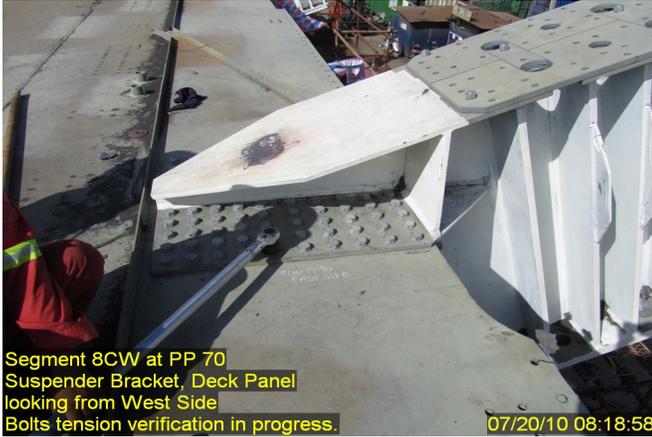
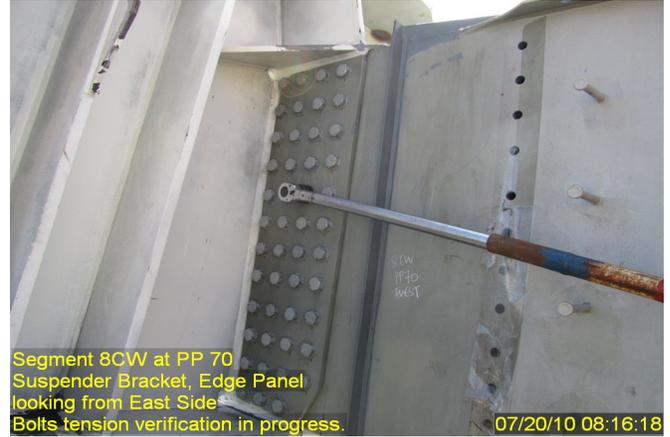
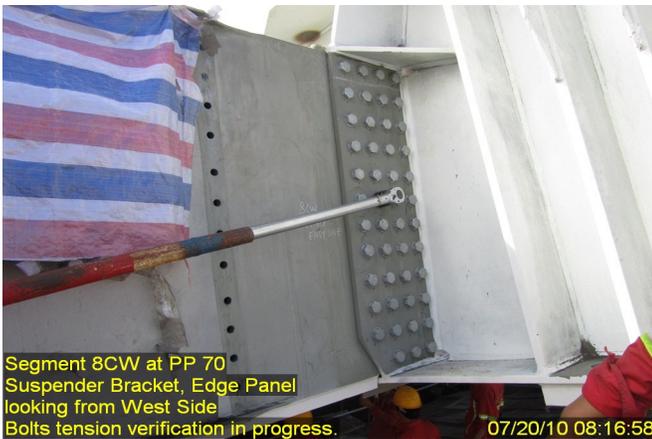
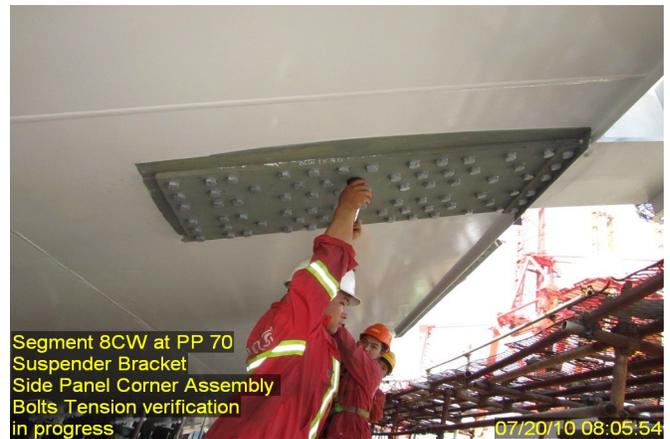
The manual torque wrench used to verify tension was S/N XO-871. Please reference the pictures attached for more comprehensive details.
