DEPARTMENT OF TRANSPORTATION

Contract #: 04-0120F4Cty: SF/ALA Rte: 80 PM: 13.2/13.9File #: 69.28**WELDING INSPECTION REPORT****Resident Engineer:** Pursell, Gary**Address:** 333 Burma Road**City:** Oakland, CA 94607**Report No:** WIR-015718**Date Inspected:** 08-Jul-2010**Project Name:** SAS Superstructure**OSM Arrival Time:** 700**Prime Contractor:** American Bridge/Fluor Enterprises, a JV**OSM Departure Time:** 1900**Contractor:** Zhenhua Port Machinery Company, Ltd (ZPMC), Changxing Island **Location:** Shanghai, China**CWI Name:** Mr. Zhao Chen Sun**CWI Present:** Yes No**Inspected CWI report:** Yes No N/A**Rod Oven in Use:** Yes No N/A**Electrode to specification:** Yes No N/A**Weld Procedures Followed:** Yes No N/A**Qualified Welders:** Yes No N/A**Verified Joint Fit-up:** Yes No N/A**Approved Drawings:** Yes No N/A**Approved WPS:** Yes No N/A**Delayed / Cancelled:** Yes No N/A**Bridge No:** 34-0006**Component:** Tower**Summary of Items Observed:**

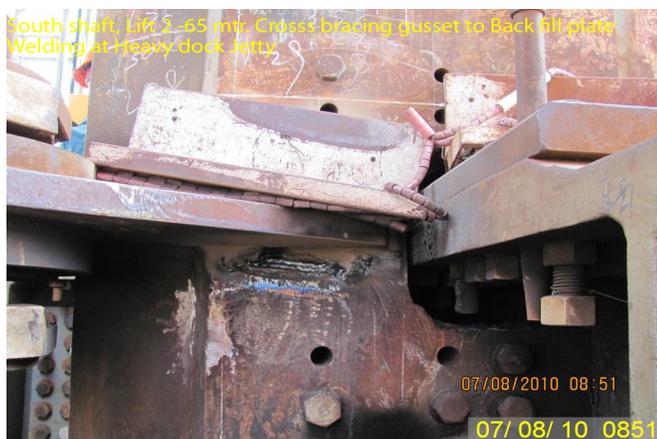
1. This QA inspector, Baskar Govindarajan, observed, ZPMC qualified welding personnel identified as 044511 perform SMAW Repair welding on; Cross bracing gusset to Back fill plate in South shaft, Lift 2, 65 mtr. elevation at Tower trial assembly area and the weld joint is identified as SSD1-SA 164 C/F-10. ZPMC CWI Identified as Mr. Zhao Chen Sun. The welding parameters as measured using QC's calibrated instruments appeared to be in general compliance with WPS-485-SMAW-2G (2F)-FCM-Repair-1. (Photo attached).

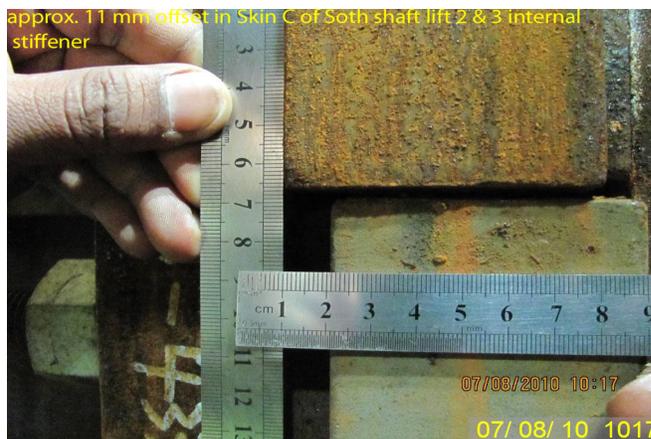
2. This QA inspector, Baskar Govindarajan performed Dimensional verification of Gap, Misalignment of Interior splice stiffeners on top and bottom side of South Shaft Lift 2 & 3 Connections. This Readings were taken along with QA Inspector Mr. Sandeep Kumar (B 227) and these dimensions measured in Skin A, B, C, D and E. During this, QA Inspector observed offset of approximately 11 mm in lower splices between Lift 2 and interior splice, Skin C stiffener. All the readings taken were handed over to Task Leader. (Photograph showing the Offset is attached with this Report)
