**DEPARTMENT OF TRANSPORTATION**

Contract #: 04-0120F4Cty: SF/ALA Rte: 80 PM: 13.2/13.9File #: 69.28**WELDING INSPECTION REPORT****Resident Engineer:** Pursell, Gary**Address:** 333 Burma Road**City:** Oakland, CA 94607**Report No:** WIR-015730**Date Inspected:** 10-Jul-2010**Project Name:** SAS Superstructure**OSM Arrival Time:** 700**Prime Contractor:** American Bridge/Fluor Enterprises, a JV**OSM Departure Time:** 1900**Contractor:** Zhenhua Port Machinery Company, Ltd (ZPMC), Changxing Island **Location:** Shanghai, China

**Bridge No:** 34-0006**Component:** Tower & OBG Components**Summary of Items Observed:**

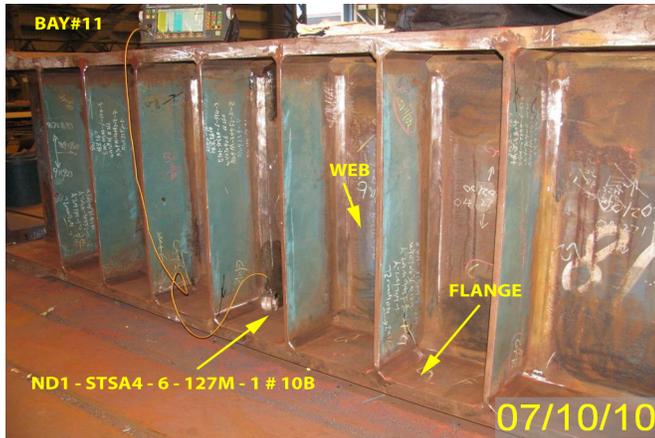
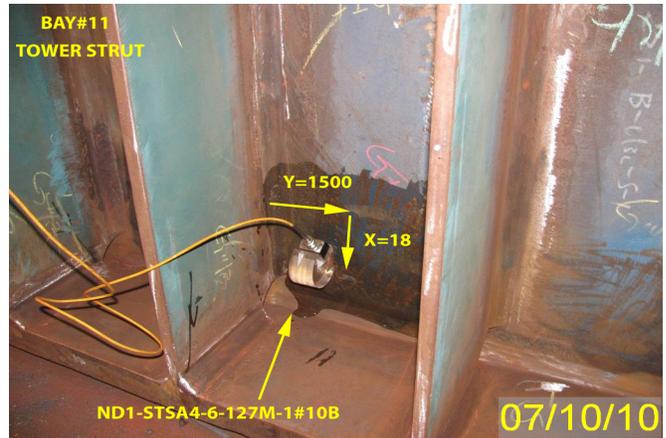
During random 10% verification Ultrasonic Testing (UT) of Tower Strut, this Quality Assurance Inspector (QA) discovered the following issue:

One (1) Class “A” non conforming longitudinal indication measuring approximately 15 mm in length.

The weld is a complete joint penetration (CJP) T-joint, joining Web to Flange and is identified as ND1-STSA4-6-127M-1.

The discontinuity rating is +9, Class “A” reject

Depth of the discontinuity from face B is approximately 15 mm, and Y location was 1500mm.

The indication is in an area previously tested and accepted by ZPMC QC UT technicians.
