**DEPARTMENT OF TRANSPORTATION**

Contract #: 04-0120F4Cty: SF/ALA Rte: 80 PM: 13.2/13.9File #: 1.28**WELDING INSPECTION REPORT****Resident Engineer:** Pursell, Gary**Address:** 333 Burma Road**City:** Oakland, CA 94607**Report No:** WIR-015742**Date Inspected:** 20-Jul-2010**Project Name:** SAS Superstructure**OSM Arrival Time:** 1000**Prime Contractor:** American Bridge/Fluor Enterprises, a JV**OSM Departure Time:** 1830**Contractor:** American Bridge/Fluor Enterprises, a JV**Location:** Job Site**CWI Name:** See Below**CWI Present:** Yes No**Inspected CWI report:** Yes No N/A**Rod Oven in Use:** Yes No N/A**Electrode to specification:** Yes No N/A**Weld Procedures Followed:** Yes No N/A**Qualified Welders:** Yes No N/A**Verified Joint Fit-up:** Yes No N/A**Approved Drawings:** Yes No N/A**Approved WPS:** Yes No N/A**Delayed / Cancelled:** Yes No N/A**Bridge No:** 34-0006**Component:** Orthotropic Box Girders**Summary of Items Observed:**

# WELDING INSPECTION REPORT

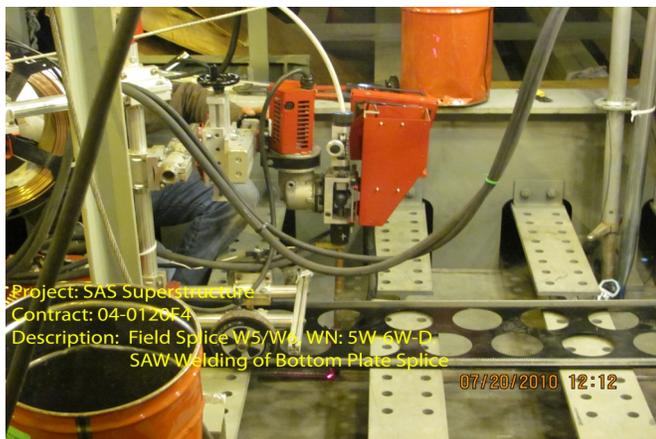
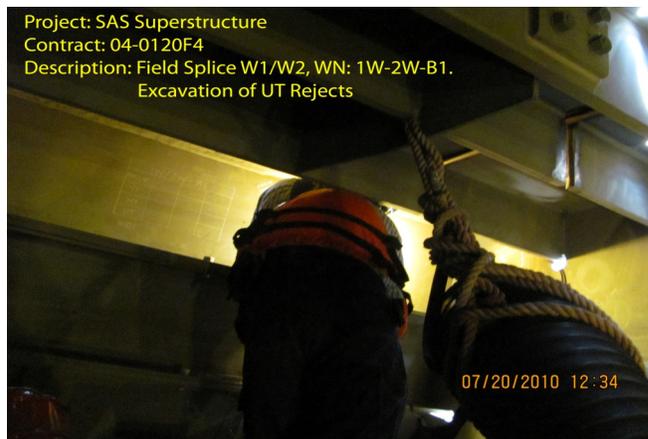
The digital photographs on page 3 of this report illustrate the work observed during this scheduled shift.
