**DEPARTMENT OF TRANSPORTATION**

Contract #: 04-0120F4Cty: SF/Ala Rte: 80 PM: 13.2/13.9File #: 69.28**WELDING INSPECTION REPORT****Resident Engineer:** Pursell, Gary**Address:** 333 Burma Road**City:** Oakland, CA 94607**Report No:** WIR-015751**Date Inspected:** 17-Jul-2010**Project Name:** SAS Superstructure**OSM Arrival Time:** 1900**Prime Contractor:** American Bridge/Fluor Enterprises, a JV**OSM Departure Time:** 700**Contractor:** Zhenhua Port Machinery Company, Ltd (ZPMC), Changxing Island **Location:** Shanghai, China**CWI Name:** See below**CWI Present:** Yes No**Inspected CWI report:** Yes No N/A**Rod Oven in Use:** Yes No N/A**Electrode to specification:** Yes No N/A**Weld Procedures Followed:** Yes No N/A**Qualified Welders:** Yes No N/A**Verified Joint Fit-up:** Yes No N/A**Approved Drawings:** Yes No N/A**Approved WPS:** Yes No N/A**Delayed / Cancelled:** Yes No N/A**Bridge No:** 34-0006**Component:** Tower and OBG Components**Summary of Items Observed:**

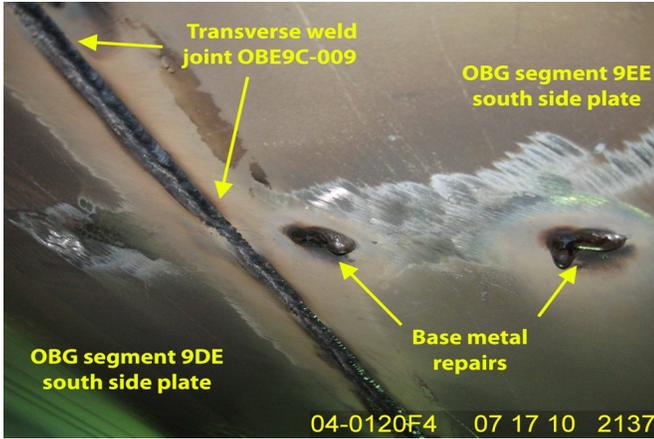
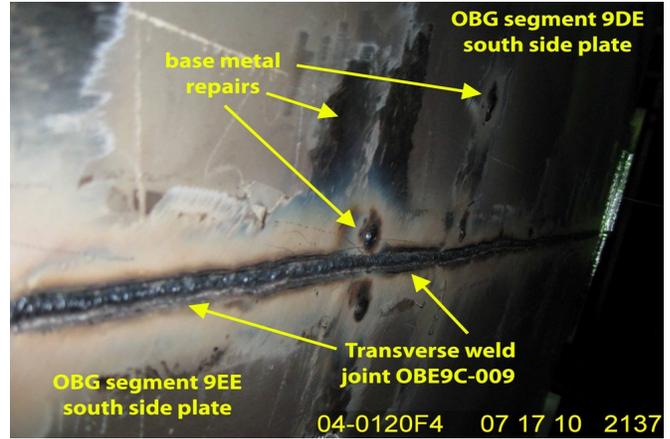
The above noted welders at OBE9C-009, 010 also performed SMAW welding of base metal repairs caused by the removal of temporary alignment plates adjacent the transverse weld joints. See photos below. QC was identified as QC2. Welding variables recorded by QC2 appeared to comply with WPS-345-SMAW-4G(4F)-FCM-repair as listed on B-CWR1679, dated 5/25/10, presented to this QA Inspector by QC2. QC2 assured this QA Inspector that these areas of repair would be ground and magnetic particle tested. Also at this location and appearing to be monitoring the welding operation were ABF Representatives Cao Hai Zhou and Wang Zhong Yuan.
