DEPARTMENT OF TRANSPORTATION

Contract #: 04-0120F4Cty: SF/ALA Rte: 80 PM: 13.2/13.9File #: 1.28**WELDING INSPECTION REPORT****Resident Engineer:** Pursell, Gary**Address:** 333 Burma Road**City:** Oakland, CA 94607**Report No:** WIR-015754**Date Inspected:** 21-Jul-2010**Project Name:** SAS Superstructure**OSM Arrival Time:** 700**Prime Contractor:** American Bridge/Fluor Enterprises, a JV**OSM Departure Time:** 1530**Contractor:** American Bridge/Fluor Enterprises, a JV**Location:** Jobsite**CWI Name:** See below**CWI Present:** Yes No**Inspected CWI report:** Yes No N/A**Rod Oven in Use:** Yes No N/A**Electrode to specification:** Yes No N/A**Weld Procedures Followed:** Yes No N/A**Qualified Welders:** Yes No N/A**Verified Joint Fit-up:** Yes No N/A**Approved Drawings:** Yes No N/A**Approved WPS:** Yes No N/A**Delayed / Cancelled:** Yes No N/A**Bridge No:** 34-0006**Component:** SAS OBG**Summary of Items Observed:**

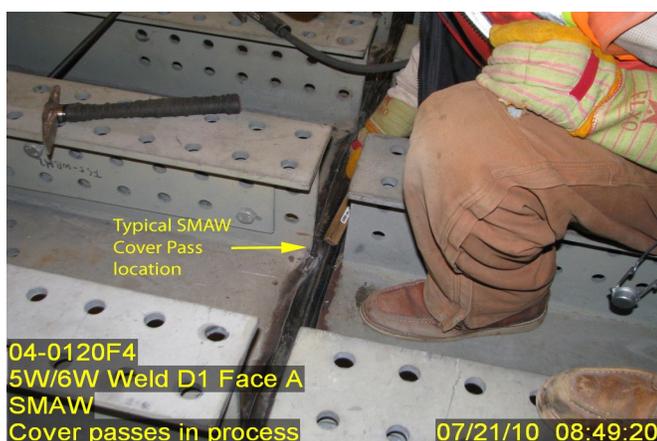
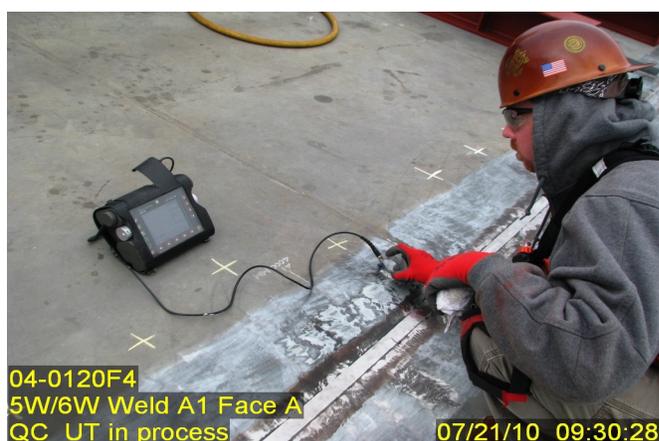
4). OBG Field Splice 5W/6W Weld ID: A1, A2 & A3, Face A

The QAI periodically observed SE QC Inspector Steve McConnel performing Ultrasonic Testing (UT) from the A Face of OBG Field Splice 5W/6W Weld ID: A1, A2, A3 & A4. See photo below. Mr. McConnel utilized the UT Procedure identified as SE-UT-D1.5-CT-100 Rev.4 during the examination of the CJP. The QC technician performed the required longitudinal wave utilizing a 1" diameter transducer for base metal soundness and a .63 x .75 rectangular transducer to perform the shear wave testing during the testing for weld soundness. The QAI observed that the QC technician marked several areas that contained rejectable indications on A1. The UT examination was in process during this shift and appeared to be in general compliance with contract documents. See Summary of Conversations.

The QAI observed paint marks indicating rejectable areas in the weld and noted that no information was being recorded by the QC Steve McConnel. The QAI asked the QC if the indication information was being recorded in his log book. Mr. McConnel stated that he was laying everything out first and would come back to re-scan and

gather the data. He stated to the QAI that in the past when QC recorded the information on the steel adjacent to the flaw (including the depth), the contractor would sometimes begin excavating repairs prior to the QC completing the testing.
