DEPARTMENT OF TRANSPORTATION

Quality Assurance and Source Inspection

Contract #: 04-0120F4Cty: SF/ALA Rte: 80 PM: 13.2/13.9File #: 1.28**WELDING INSPECTION REPORT****Resident Engineer:** Pursell, Gary**Address:** 333 Burma Road**City:** Oakland, CA 94607**Report No:** WIR-015767**Date Inspected:** 21-Jul-2010**Project Name:** SAS Superstructure**OSM Arrival Time:** 630**Prime Contractor:** American Bridge/Fluor Enterprises, a JV**OSM Departure Time:** 1500**Contractor:** American Bridge/Fluor Enterprises, a JV**Location:** Job Site**CWI Name:** See below**CWI Present:** Yes No**Inspected CWI report:** Yes No N/A**Rod Oven in Use:** Yes No N/A**Electrode to specification:** Yes No N/A**Weld Procedures Followed:** Yes No N/A**Qualified Welders:** Yes No N/A**Verified Joint Fit-up:** Yes No N/A**Approved Drawings:** Yes No N/A**Approved WPS:** Yes No N/A**Delayed / Cancelled:** Yes No N/A**Bridge No:** 34-0006**Component:** SAS OBG**Summary of Items Observed:**

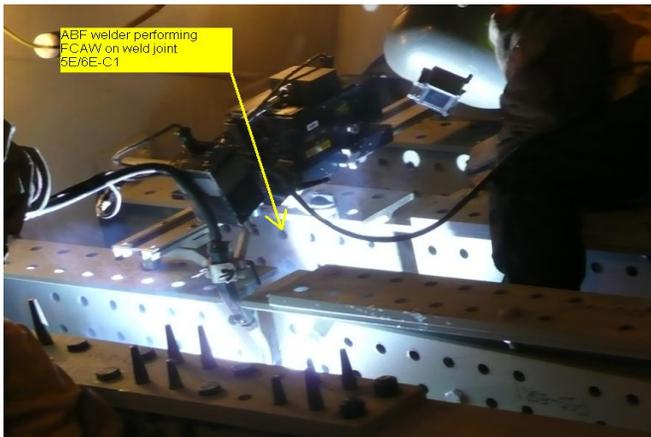
The QA Inspector randomly observed the ABF welder Song Tao Hunag had previously started the induction heating blankets on the inside of OBG to ensure the minimum required preheat of 150°F was achieved prior to welding. The QA Inspector randomly verified utilizing a 150°F temperature indicating marker and noted the minimum required preheat had been achieved. The QA Inspector observed the ABF welder to be utilizing the semi automated flux cored arc welding (FCAW) for the above identified weld joint. The QA Inspector randomly observed the Smith Emery (SE) QC Inspector identified as Bonifacio Daquinag set the FCAW machine to the parameters of the approved WPS identified as ABF-WPS-D1.5-3042-B-1. The QA Inspector randomly observed the FCAW parameters were 236 Amps, 24.1 Volts and a travel speed of 250mm/min. The QA Inspector noted the FCAW root pass was welded on the previous day shift. The QA Inspector performed a random visual inspection of the completed root pass in weld segment C1 and noted it did appear to meet the general requirements of the contract documents. The QA Inspector randomly observed the ABF welder identified above continue the FCAW fill passes on C1. The QA Inspector noted the ABF welders spent the remainder of the shift performing the FCAW fill passes (pictured below).
