**DEPARTMENT OF TRANSPORTATION**

Contract #: 04-0120F4Cty: SF/ALA Rte: 80 PM: 13.2/13.9File #: 69.28**WELDING INSPECTION REPORT****Resident Engineer:** Pursell, Gary**Address:** 333 Burma Road**City:** Oakland, CA 94607**Report No:** WIR-015781**Date Inspected:** 25-Jul-2010**Project Name:** SAS Superstructure**OSM Arrival Time:** 700**Prime Contractor:** American Bridge/Fluor Enterprises, a JV**OSM Departure Time:** 1900**Contractor:** Zhenhua Port Machinery Company, Ltd (ZPMC), Changxing Island **Location:** Shanghai, China**CWI Name:** Mr. Xu Le Feng**CWI Present:** Yes No**Inspected CWI report:** Yes No N/A**Rod Oven in Use:** Yes No N/A**Electrode to specification:** Yes No N/A**Weld Procedures Followed:** Yes No N/A**Qualified Welders:** Yes No N/A**Verified Joint Fit-up:** Yes No N/A**Approved Drawings:** Yes No N/A**Approved WPS:** Yes No N/A**Delayed / Cancelled:** Yes No N/A**Bridge No:** 34-0006**Component:** Tower**Summary of Items Observed:**

# WELDING INSPECTION REPORT

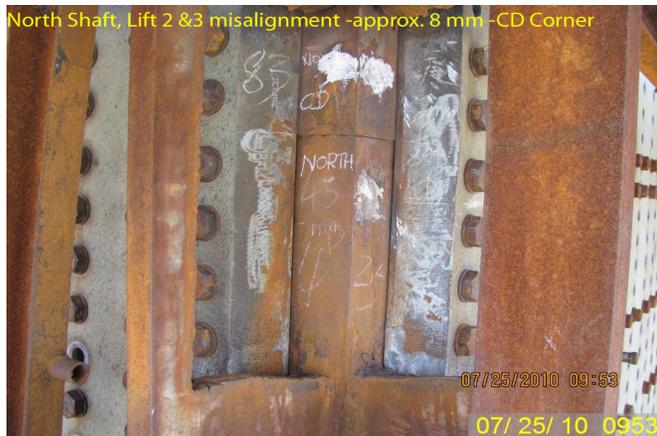
This QA inspector, Baskar Govindarajan, Performed, Lift 2 & 3, External alignment measurements which includes, Top, Bottom and side Gap between Splice and Tower Skins, Horizontal and Vertical Flatness near Splice plates, Distance between Splice plate and Tower Skin Edges of all corners, Lift 2 & 3 misalignment in all corners. These measurements carried out along with QA Inspector Mr. Ragavendra Reddy (B 308) in South and North tower on Skin A, B, C, D and E. All the reading has been handed over to Task Leader. (Photo of misalignment of approx. 8mm observed in North shaft between Lift 2 & 3 in Skin C, CD Corner is attached)
