**DEPARTMENT OF TRANSPORTATION**

Contract #: 04-0120F4Cty: SF/ALA Rte: 80 PM: 13.2/13.9File #: 69.28**WELDING INSPECTION REPORT****Resident Engineer:** Pursell, Gary**Address:** 333 Burma Road**City:** Oakland, CA 94607**Report No:** WIR-015829**Date Inspected:** 25-Jul-2010**Project Name:** SAS Superstructure**OSM Arrival Time:** 1900**Prime Contractor:** American Bridge/Fluor Enterprises, a JV**OSM Departure Time:** 700**Contractor:** Zhenhua Port Machinery Company, Ltd (ZPMC), Changxing Island **Location:** Shanghai, China**CWI Name:** See Below**CWI Present:** Yes No**Inspected CWI report:** Yes No N/A**Rod Oven in Use:** Yes No N/A**Electrode to specification:** Yes No N/A**Weld Procedures Followed:** Yes No N/A**Qualified Welders:** Yes No N/A**Verified Joint Fit-up:** Yes No N/A**Approved Drawings:** Yes No N/A**Approved WPS:** Yes No N/A**Delayed / Cancelled:** Yes No N/A**Bridge No:** 34-0006**Component:** OBG**Summary of Items Observed:**

**OBG Segment Trial Assembly**

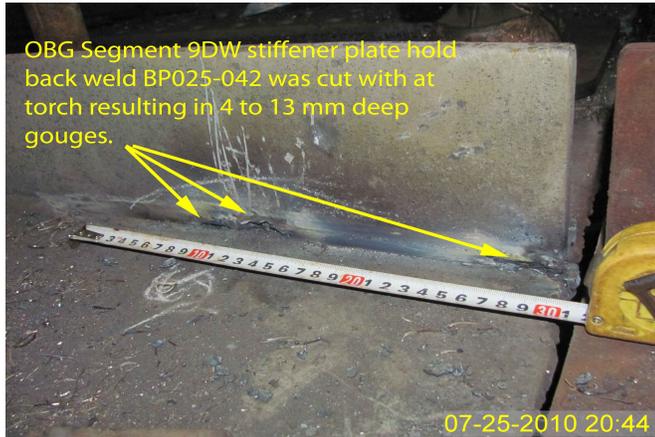
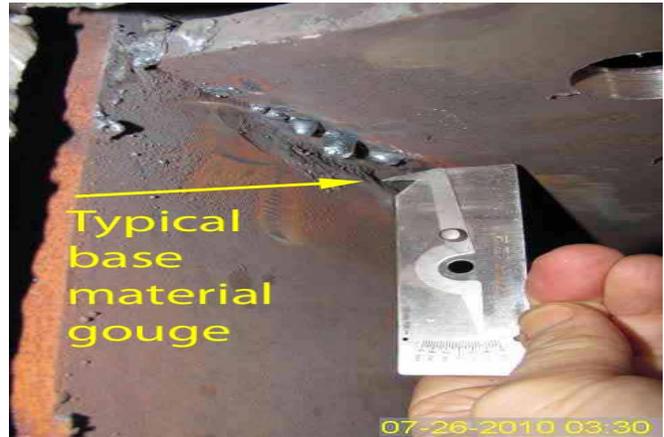
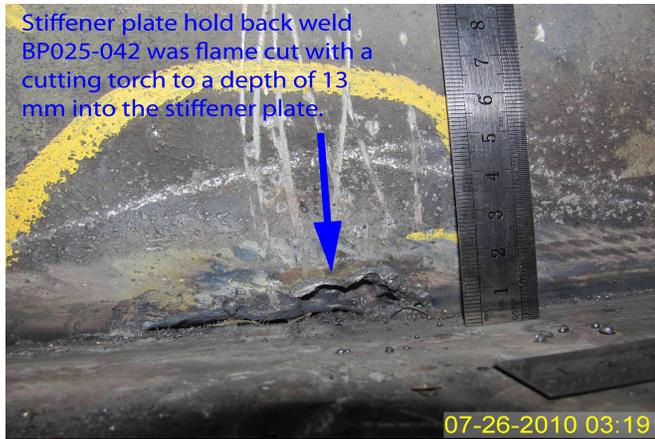
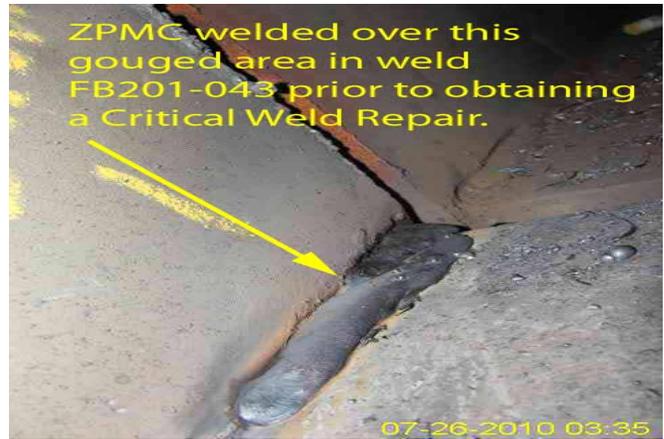
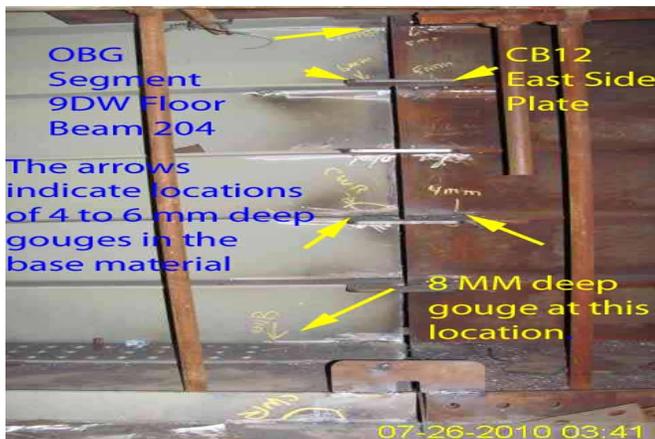
- ZPMC personnel have used an acetylene/oxygen torch to remove numerous Seismic Performance Critical Material (SPCM) and non-SPCM stiffener plate and side to bottom panel hold back tack welds.

- The base material of stiffener plates and adjacent SPCM base material were damaged during tack weld removal.
- SPCM and non-SPCM base metal damage include gouges ranging from 3mm to 13mm deep. A number of these areas have been weld repaired prior to ZPMC obtaining Engineers approval. (see photos below)

- SPCM weld identified as BP025-042 has a gouge depth, into the non-SPCM stiffener, up to 13 mm and a length of 130 mm. (see photos below)
- The SPCM hold back corner weld joint between floor beam SP208A and BP205A has a gouge depth of 8mm and other portions of this weld joint appear to have had similar gouges welded over prior to obtaining CWR.

- The two above mentioned SPCM welds are not listed on Welding Repair Report B-WR14103.
- ZPMC CWI stated the weld removal and repairs are authorized by Welding Repair Report B-WR14103.
