DEPARTMENT OF TRANSPORTATION

Quality Assurance and Source Inspection

Contract #: 04-0120F4Cty: SF/ALA Rte: 80 PM: 13.2/13.9File #: 1.28**WELDING INSPECTION REPORT****Resident Engineer:** Pursell, Gary**Address:** 333 Burma Road**City:** Oakland, CA 94607**Report No:** WIR-015833**Date Inspected:** 23-Jul-2010**Project Name:** SAS Superstructure**OSM Arrival Time:** 1000**Prime Contractor:** American Bridge/Fluor Enterprises, a JV**OSM Departure Time:** 1830**Contractor:** American Bridge/Fluor Enterprises, a JV**Location:** Job Site**CWI Name:** See Below**CWI Present:** Yes No**Inspected CWI report:** Yes No N/A**Rod Oven in Use:** Yes No N/A**Electrode to specification:** Yes No N/A**Weld Procedures Followed:** Yes No N/A**Qualified Welders:** Yes No N/A**Verified Joint Fit-up:** Yes No N/A**Approved Drawings:** Yes No N/A**Approved WPS:** Yes No N/A**Delayed / Cancelled:** Yes No N/A**Bridge No:** 34-0006**Component:** Orthotropic Box Girders**Summary of Items Observed:**

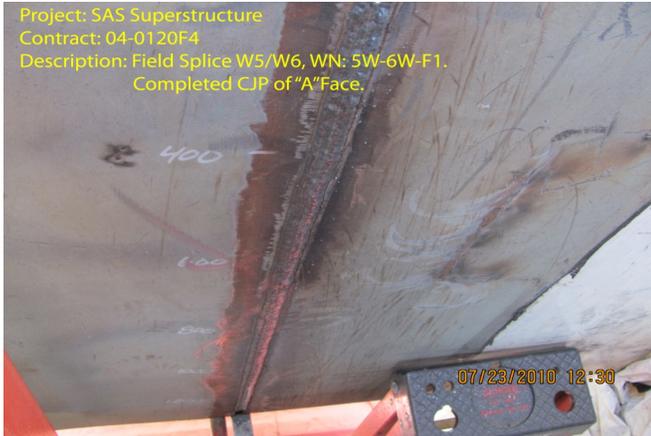
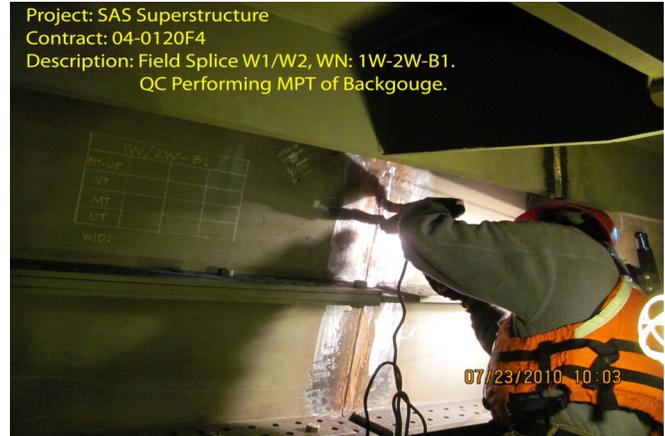
The digital photographs on page 3 of this report illustrate the work observed during this scheduled shift.
