DEPARTMENT OF TRANSPORTATION

Contract #: 04-0120F4Cty: SF/ALA Rte: 80 PM: 13.2/13.9File #: 1.28**WELDING INSPECTION REPORT****Resident Engineer:** Pursell, Gary**Address:** 333 Burma Road**City:** Oakland, CA 94607**Report No:** WIR-015836**Date Inspected:** 26-Jul-2010**Project Name:** SAS Superstructure**OSM Arrival Time:** 1000**Prime Contractor:** American Bridge/Fluor Enterprises, a JV**OSM Departure Time:** 1830**Contractor:** American Bridge/Fluor Enterprises, a JV**Location:** Job Site**CWI Name:** John Pagliero**CWI Present:** Yes No**Inspected CWI report:** Yes No N/A**Rod Oven in Use:** Yes No N/A**Electrode to specification:** Yes No N/A**Weld Procedures Followed:** Yes No N/A**Qualified Welders:** Yes No N/A**Verified Joint Fit-up:** Yes No N/A**Approved Drawings:** Yes No N/A**Approved WPS:** Yes No N/A**Delayed / Cancelled:** Yes No N/A**Bridge No:** 34-0006**Component:** Orthotropic Box Girder**Summary of Items Observed:**

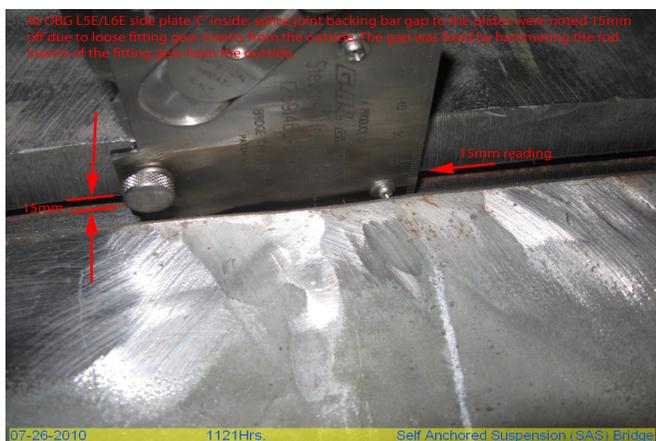
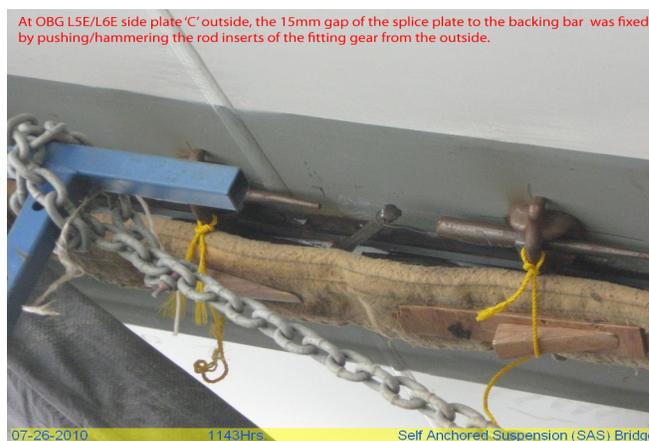
At OBG L5E/L6E side plate 'C' (0mm to 3110mm) inside, QA noted the welding of the splice at this location was completed and the welder has moved to location 7478mm to 9855mm. Before the welder moved to the new location, ABF bolting crew personnel were observed removing the connection plates that were temporarily bolted to hold the OBG splice in place. After the connection plates' removal, welder Sungtao, Huang ID # 3794 fixed the backing bar from the other side that came loose due to frequent chipping during welding. The welder welded the root pass by hand with the FCAW-G in 3G (vertical) position. The welder continued to perform CJP groove (splice) welding fill pass on the splice butt joint. The welder was observed performing automatic welding in the 3G (vertical) position utilizing a dual shield Flux Cored Arc Welding (FCAW-G) with E71T-1M, 1/16" diameter wire electrode and implementing Caltrans approved Welding Procedure Specification (WPS)

At OBG L4E/L5E side plate 'E' outside, QA randomly observed ABF personnel continuing to perform plasma arc gouging on the backing bar removal of the splice butt joint. The personnel were using an Esab plasma arc gouging machine that has the nozzle holder attached to a Bug-o track. Gouging of the backing bar was not completed today and should continue tomorrow.
