DEPARTMENT OF TRANSPORTATION

Quality Assurance and Source Inspection

Contract #: 04-0120F4Cty: SF/ALA Rte: 80 PM: 13.2/13.9File #: 1.28**WELDING INSPECTION REPORT****Resident Engineer:** Pursell, Gary**Address:** 333 Burma Road**City:** Oakland, CA 94607**Report No:** WIR-015838**Date Inspected:** 27-Jul-2010**Project Name:** SAS Superstructure**OSM Arrival Time:** 700**Prime Contractor:** American Bridge/Fluor Enterprises, a JV**OSM Departure Time:** 1530**Contractor:** American Bridge/Fluor Enterprises, a JV**Location:** Jobsite**CWI Name:** See below**CWI Present:** Yes No**Inspected CWI report:** Yes No N/A**Rod Oven in Use:** Yes No N/A**Electrode to specification:** Yes No N/A**Weld Procedures Followed:** Yes No N/A**Qualified Welders:** Yes No N/A**Verified Joint Fit-up:** Yes No N/A**Approved Drawings:** Yes No N/A**Approved WPS:** Yes No N/A**Delayed / Cancelled:** Yes No N/A**Bridge No:** 34-0006**Component:** SAS OBG**Summary of Items Observed:**

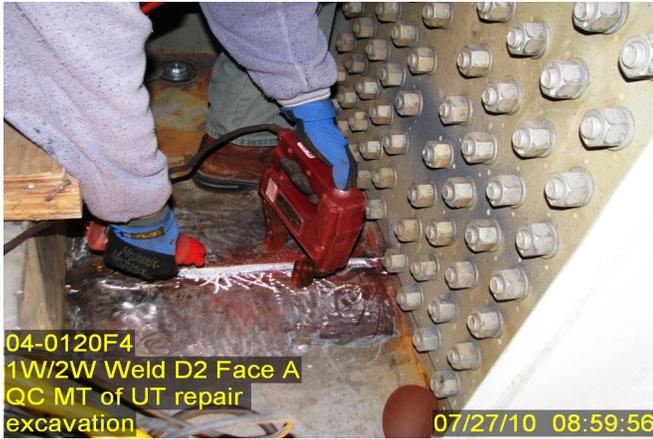
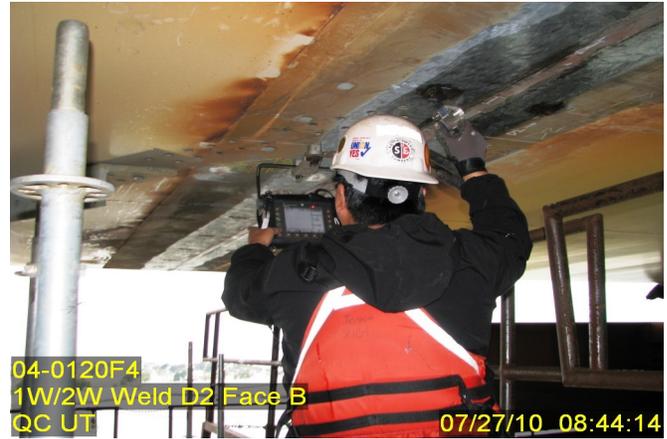
The QAI periodically observed AB/F approved welder Fred Kaddu (ID 2188) grinding to excavate (1) one Ultrasonic Testing (UT) reject area from the A face of the splice weld. The excavated area contained several UT rejectable indications that were in close proximity to one another. The QAI observed QC Inspector Tom Pasqualone performing periodic Magnetic Particle Testing (MT) to determine when the indication was completely removed. See photo below. The excavated area was determined to be clean and the final dimensions were measured by the QAI to be Length = 360mm, Width = 23mm and the Depth = 25mm. The QAI observed that the performance and evaluation of the MT appeared to comply with the MT procedure identified as SE-MT-CT-D1. 5-101 Rev. 4. Repair welding was not accomplished at this location during the QA Inspectors shift and the work at this location appeared to be in general compliance with contract documents.

The QAI periodically observed QC Inspector Tom Pasqualone performing Ultrasonic Testing (UT) from the A Face of OBG Field Splice 1W/2W Weld ID: D1. Prior to observing the testing the QAI observed QC Mr. Pasqualone performing the required calibration check of the GE USM 35 UT Instrument and the 70° Search Unit. The QAI observed Mr. Pasqualone perform a calibration check of the transducer index point, the transducer sound path angle, the horizontal sweep distance and the sensitivity. The calibration check appeared to be in compliance with contract documents and the QAI observed that Mr. Pasqualone set the reference level at 50% full screen height with a zero reference level sensitivity of 51dB. The QAI observed Mr. Pasqualone utilized the UT Procedure identified as SE-UT-D1.5-CT-100 Rev.4 during the examination of the splice weld. The QC technician performed the required shear wave testing during the testing for weld soundness utilizing a .63 x .75 rectangular transducer. The UT examination was not completed from face A during the QA Inspectors shift and the work at this location appeared to be in general compliance with contract documents.

The QAI periodically observed QC Inspector Jesse Cayabyab performing UT from the B Face of OBG Field Splice 1W/2W Weld ID: D1& D2. The QAI periodically observed that Mr. Cayabyab utilized the UT Procedure identified as SE-UT-D1.5-CT-100 Rev.4 during the examination of the splice weld. The QC technician performed the required longitudinal wave testing utilizing a 1" diameter transducer for base metal soundness and performed the required shear wave testing during the testing for weld soundness utilizing a .63 x .75 rectangular transducer. The UT examination was completed from face A during the QA Inspectors shift and the work at this location appeared to be in general compliance with contract documents.

The QAI periodically observed SE QC Inspector Steve McConnel performing UT of OBG Field Splice 3W/4W Weld ID: F1 from the B Face. Mr. McConnel utilized the UT Procedure identified as SE-UT-D1.5-CT-100 Rev.4 during the examination of the splice weld. The QC technician performed the required shear wave testing during the testing for weld soundness utilizing a .63 x .75 rectangular transducer. The UT examination was completed from face B during this shift and the QAI observed that the QC inspector had marked several rejectable indications on the steel. See Summary of Conversations below.
