DEPARTMENT OF TRANSPORTATION

Quality Assurance and Source Inspection

Contract #: 04-0120F4Cty: SF/ALA Rte: 80 PM: 13.2/13.9File #: 1.28**WELDING INSPECTION REPORT****Resident Engineer:** Pursell, Gary**Address:** 333 Burma Road**City:** Oakland, CA 94607**Report No:** WIR-015839**Date Inspected:** 27-Jul-2010**Project Name:** SAS Superstructure**OSM Arrival Time:** 1000**Prime Contractor:** American Bridge/Fluor Enterprises, a JV**OSM Departure Time:** 1830**Contractor:** American Bridge/Fluor Enterprises, a JV**Location:** Job Site**CWI Name:** See Below**CWI Present:** Yes No**Inspected CWI report:** Yes No N/A**Rod Oven in Use:** Yes No N/A**Electrode to specification:** Yes No N/A**Weld Procedures Followed:** Yes No N/A**Qualified Welders:** Yes No N/A**Verified Joint Fit-up:** Yes No N/A**Approved Drawings:** Yes No N/A**Approved WPS:** Yes No N/A**Delayed / Cancelled:** Yes No N/A**Bridge No:** 34-0006**Component:** Orthotropic Box Girders**Summary of Items Observed:**

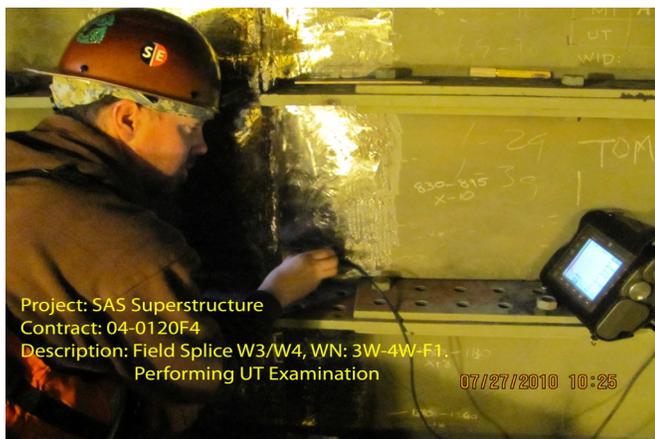
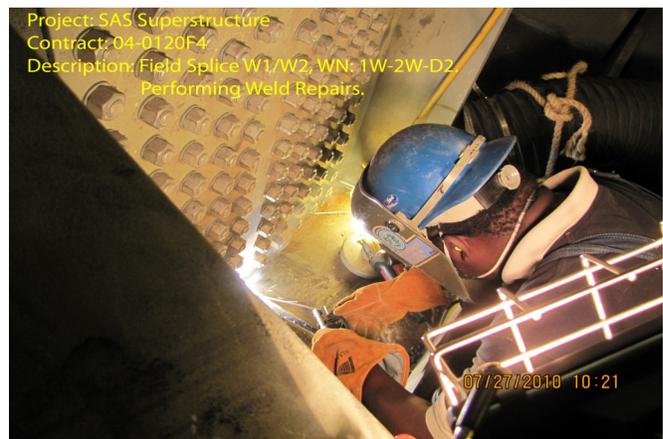
The digital photographs below illustrate the work observed during this scheduled shift.
