**DEPARTMENT OF TRANSPORTATION**

Contract #: 04-0120F4Cty: SF/ALA Rte: 80 PM: 13.2/13.9File #: 69.28**WELDING INSPECTION REPORT****Resident Engineer:** Pursell, Gary**Address:** 333 Burma Road**City:** Oakland, CA 94607**Report No:** WIR-015859**Date Inspected:** 24-Jul-2010**Project Name:** SAS Superstructure**OSM Arrival Time:** 700**Prime Contractor:** American Bridge/Fluor Enterprises, a JV**OSM Departure Time:** 1900**Contractor:** Zhenhua Port Machinery Company, Ltd (ZPMC), Changxing Island **Location:** Shanghai, China

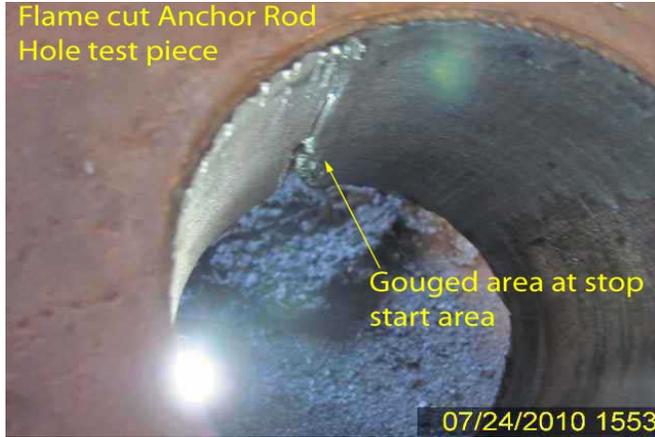
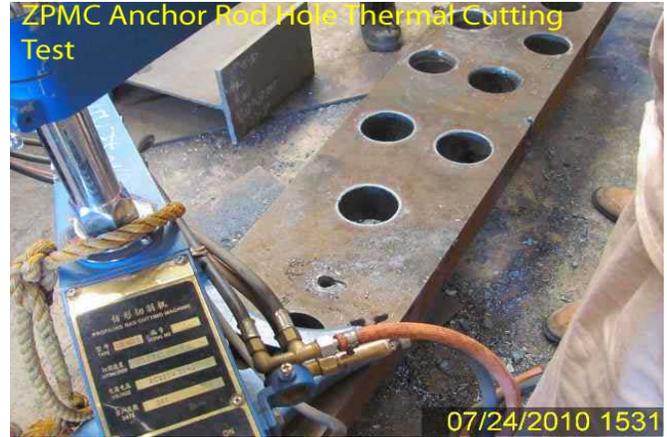
Caltrans QA observed ZPMC personnel performing flame cutting on 100mm thick test piece to simulate the anchor rod holes for OBG segment 13AW and 13AE shear key plate. The contract documents require the anchor bolt holes will be drilled. Caltrans QA observed a gouge area on the 100 mm diameter hole at the start and stop location. Please see the attached photo below for additional information.
