Contract #: 04-0120F4Cty: SF/ALA Rte: 80 PM: 13.2/13.9File #: 69.28**WELDING INSPECTION REPORT****Resident Engineer:** Pursell, Gary**Address:** 333 Burma Road**City:** Oakland, CA 94607**Report No:** WIR-015887**Date Inspected:** 28-Jul-2010**Project Name:** SAS Superstructure**OSM Arrival Time:** 700**Prime Contractor:** American Bridge/Fluor Enterprises, a JV**OSM Departure Time:** 1900**Contractor:** Zhenhua Port Machinery Company, Ltd (ZPMC), Changxing Island **Location:** Shanghai, China**CWI Name:** Zhu Zhong Hai**CWI Present:** Yes No**Inspected CWI report:** Yes No N/A**Rod Oven in Use:** Yes No N/A**Electrode to specification:** Yes No N/A**Weld Procedures Followed:** Yes No N/A**Qualified Welders:** Yes No N/A**Verified Joint Fit-up:** Yes No N/A**Approved Drawings:** Yes No N/A**Approved WPS:** Yes No N/A**Delayed / Cancelled:** Yes No N/A**Bridge No:** 34-0006**Component:** Orthotropic Box Girder (OBG)**Summary of Items Observed:**

WELDING INSPECTION REPORT

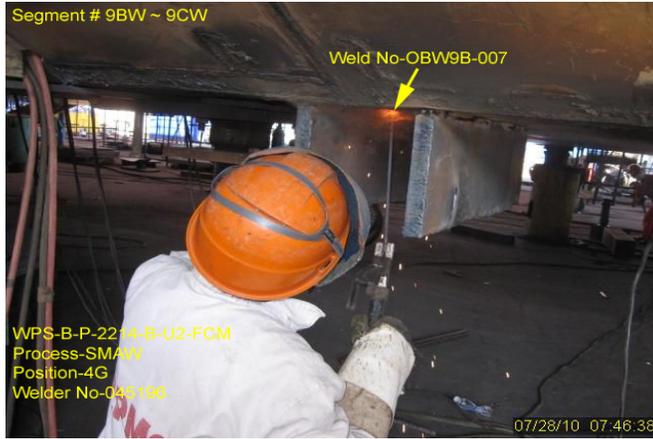
Segment # 9BW ~ 9CW

This QA inspector observed, ZPMC qualified welding personnel identified as 045196 perform Shielded Metal Arc Welding (SMAW), weld joint identified as OBW9B-007; ZPMC CWI is identified as Mr. Zhu Zhang Hai. The welding parameters measured using QC’s calibrated instrument appeared to be in general compliance with WPS-B-P-2214-B-U2-FCM. See the attached Photo.

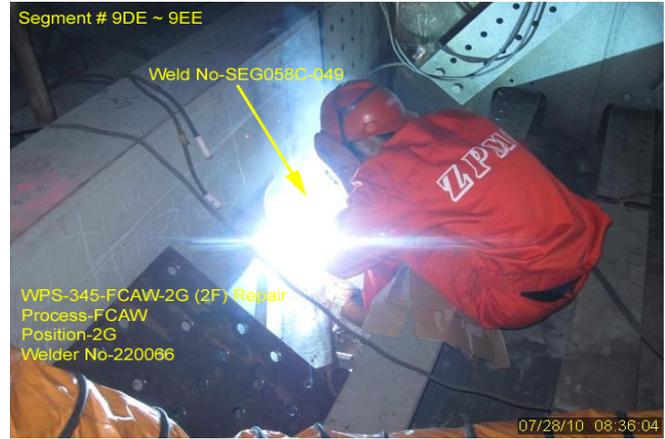
Segment # 9DE ~ 9EE

This QA inspector observed, ZPMC qualified welding personnel identified as 220066 perform Shielded Metal Arc Welding (SMAW), weld joint identified as OBE9A-008; The Welding Repair Report (WRR) was B-WR14139. ZPMC QC is identified as Mr. Wang Li Yang. The welding parameters measured using QC’s calibrated instrument appeared to be in general compliance with WPS-345-FCAW 2G (2F) Repair-1. See the attached Photo.
