**DEPARTMENT OF TRANSPORTATION**

Office of Structural Materials

Contract #: 04-0120F4Cty: SF/ALA Rte: 80 PM: 13.2/13.9File #: 1.28**WELDING INSPECTION REPORT****Resident Engineer:** Pursell, Gary**Address:** 333 Burma Road**City:** Oakland, CA 94607**Report No:** WIR-015951**Date Inspected:** 30-Jul-2010**Project Name:** SAS Superstructure**OSM Arrival Time:** 700**Prime Contractor:** American Bridge/Fluor Enterprises, a JV**OSM Departure Time:** 1530**Contractor:** American Bridge/Fluor Enterprises, a JV**Location:** Jobsite**CWI Name:** See below**CWI Present:** Yes No**Inspected CWI report:** Yes No N/A**Rod Oven in Use:** Yes No N/A**Electrode to specification:** Yes No N/A**Weld Procedures Followed:** Yes No N/A**Qualified Welders:** Yes No N/A**Verified Joint Fit-up:** Yes No N/A**Approved Drawings:** Yes No N/A**Approved WPS:** Yes No N/A**Delayed / Cancelled:** Yes No N/A**Bridge No:** 34-0006**Component:** SAS OBG**Summary of Items Observed:**

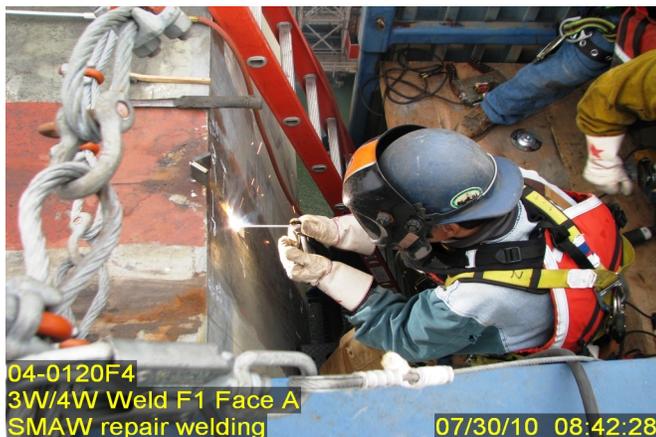
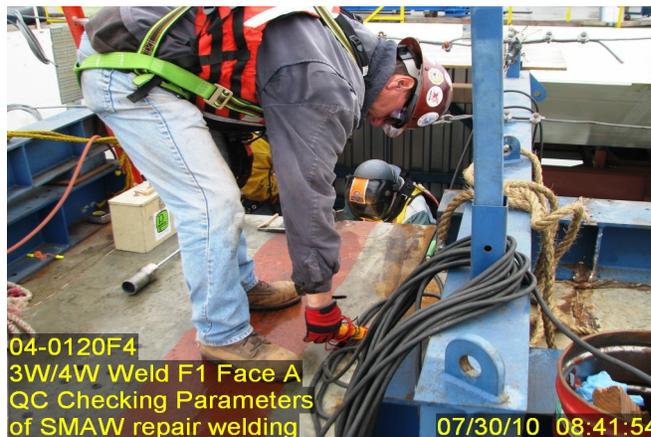
The QAI periodically observed AB/F approved welder Fred Kaddu (ID 2188) performing repair welding per the Shielded Metal Arc Welding (SMAW) process in the 1G (flat) position of repair excavations at Ultrasonic Testing (UT) reject areas from the A face. AB/F approved welder Kenneth Chappell was performing the excavating by grinding. AB/F QC Inspector Tom Pasqualone was present to monitor the progress and verify that the welding parameters were within the limits established by the approved welding Procedure Specification (WPS) identified as ABF-WPS-D1.5-1000-Repair. The QAI periodically observed QC Inspector Tom Pasqualone performing Magnetic Particle Testing (MT) of the repair excavations prior to Mr. Kaddu performing welding at the repair locations. The QAI observed that the performance and evaluation of the MT appeared to comply with the MT procedure identified as SE-MT-CT-D1.5-101 Rev. 4. Work was not completed at this location during the QA Inspectors shift and the work appeared to be in general compliance with contract documents.

reject indications in one excavated repair area on the A face of the OBG Field Splice 3W/4W Weld ID: F1. The QAI observed QC Inspector Tony Sherwood measuring the dimensions of the excavation and then directing Mr. Zhen to perform additional grinding to obtain a depth greater than the indication depth recorded on the QC UT report. The QAI observed QC Inspector Tony Sherwood measuring the depth dimension of the excavation and indicating to Mr. Zhen that the depth was adequate. Mr. Sherwood then performed Magnetic Particle Testing (MT) of the excavation to confirm the complete removal of the rejectable indication. See photo below. The QAI observed AB/F approved welder James Zhen (ID 6001) performing attachment welding of run-off tabs and then the QC inspector measuring the welding parameters during the first weld pass deposited in the repair excavation. See photo below. The QC Inspector stated to the QAI that the welding Amps were measured at 125 Amps. The QAI periodically observed the repair welding per the Shielded Metal Arc Welding (SMAW) process in the 3G (vertical) position. See photo below. QC Inspector Tony Sherwood was present to monitor the progress and identified the approved Welding Procedure Specification (WPS) to the QAI as ABF-WPS-D1.5-1000- Repair. The QAI observed that the welding amperes reported by the QC Inspector were within the limits established the identified WPS. The repair welding at this repair location was completed during the QA Inspectors shift and the work appeared to be in general compliance with contract documents.
