Contract #: 04-0120F4Cty: SF/ALA Rte: 80 PM: 13.2/13.9File #: 1.28**WELDING INSPECTION REPORT****Resident Engineer:** Pursell, Gary**Address:** 333 Burma Road**City:** Oakland, CA 94607**Report No:** WIR-015955**Date Inspected:** 28-Jul-2010**Project Name:** SAS Superstructure**OSM Arrival Time:** 630**Prime Contractor:** American Bridge/Fluor Enterprises, a JV**OSM Departure Time:** 1500**Contractor:** American Bridge/Fluor Enterprises, a JV**Location:** Job Site**CWI Name:** See below**CWI Present:** Yes No**Inspected CWI report:** Yes No N/A**Rod Oven in Use:** Yes No N/A**Electrode to specification:** Yes No N/A**Weld Procedures Followed:** Yes No N/A**Qualified Welders:** Yes No N/A**Verified Joint Fit-up:** Yes No N/A**Approved Drawings:** Yes No N/A**Approved WPS:** Yes No N/A**Delayed / Cancelled:** Yes No N/A**Bridge No:** 34-0006**Component:** SAS OBG**Summary of Items Observed:**

WELDING INSPECTION REPORT

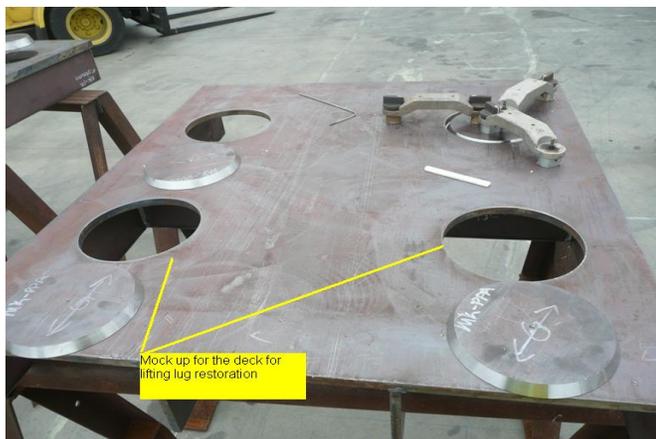
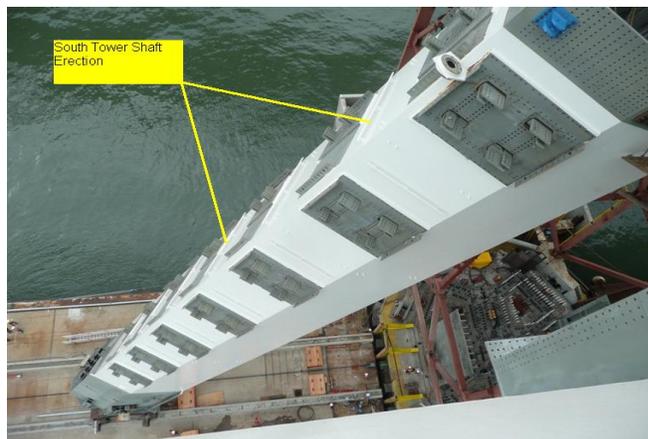
The QA Inspector randomly observed the ABF Erection personnel lift and install the South Tower Shaft on the T1 foundation. The QA Inspector noted the installation was in process for the full duration of the QA Inspectors shift.

The QA Inspector randomly observed the ABF Welding Superintendent Dan Ieraci setting up the mock ups for the welding of the lifting lug attachment holes in the top deck plate. The QA Inspector observed the mock ups consisted of the variable thickness of the top deck plates where the welding will take place. The QA Inspector randomly observe the round holes were cut at the same diameter of the holes previously used for lifting lug attachments. (see summary of conversation)

Mr. Ieraci informed the QA Inspector each mock up had 4 holes cut out and ABF will attempt to weld up each hole with a different process. Mr. Ieraci went on to inform the QA Inspector, ABF will attempt the different processes to determine which process will work the best based on the ultrasonic test results.
