**DEPARTMENT OF TRANSPORTATION**

Contract #: 04-0120F4Cty: SF/ALA Rte: 80 PM: 13.2/13.9File #: 1.28**WELDING INSPECTION REPORT****Resident Engineer:** Pursell, Gary**Address:** 333 Burma Road**City:** Oakland, CA 94607**Report No:** WIR-015956**Date Inspected:** 29-Jul-2010**Project Name:** SAS Superstructure**OSM Arrival Time:** 1000**Prime Contractor:** American Bridge/Fluor Enterprises, a JV**OSM Departure Time:** 1830**Contractor:** American Bridge/Fluor Enterprises, a JV**Location:** Job Site**CWI Name:** William Sherwood**CWI Present:** Yes No**Inspected CWI report:** Yes No N/A**Rod Oven in Use:** Yes No N/A**Electrode to specification:** Yes No N/A**Weld Procedures Followed:** Yes No N/A**Qualified Welders:** Yes No N/A**Verified Joint Fit-up:** Yes No N/A**Approved Drawings:** Yes No N/A**Approved WPS:** Yes No N/A**Delayed / Cancelled:** Yes No N/A**Bridge No:** 34-0006**Component:** Orthotropic Box Girder**Summary of Items Observed:**

# WELDING INSPECTION REPORT

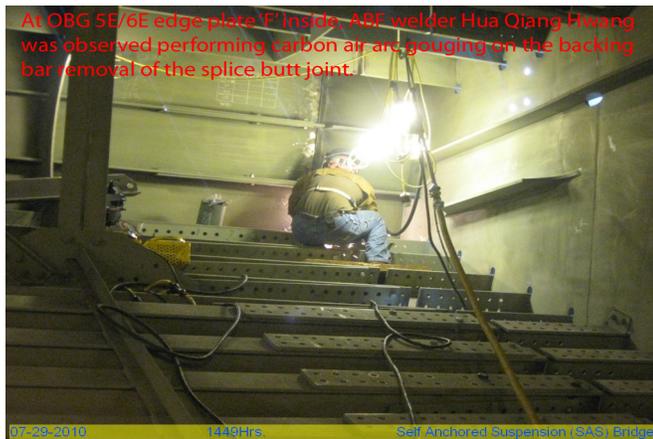
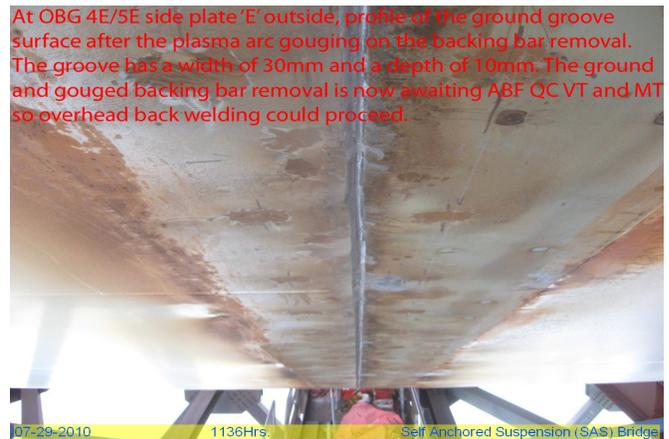
and the Bug-o track for the nozzle holder. The personnel were noted getting ready to grind the groove of the gouged surface. Also at the other side of the same OBG side plate 'E' outside, grinding of the groove gouged surface of the backing bar removal was seen completed. The profile was having a width of 30mm and depth of 8-10mm. The profile of the ground surface deemed satisfactory. It is now awaiting QC's visual test (VT) and Magnetic Particle Testing (MT) on the ground groove surface so overhead welding could proceed.

At OBG 5E/6E side plate 'E' outside, QA observed the removal of the fitting gear/temporary attachment was completed. After the removal of the temporary attachment, same ABF personnel were seen grinding the plate where the attachments were welded.

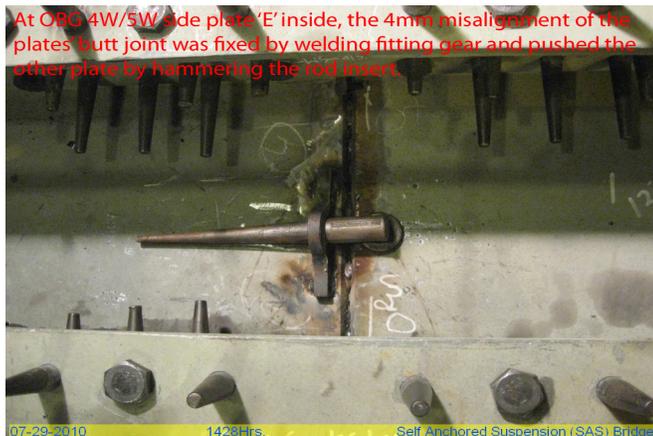
At OBG 4W/5W side plate 'E' inside, it was previously reported that there was a 4mm misalignment on the fit up of the splice butt joint. Today, QA noted that the reported misalignment was fixed by welding additional fitting gear and pushing insert rod against the fitting gear and plate of the affected area. When measured, the misalignment came down to acceptable reading of 2mm.
