DEPARTMENT OF TRANSPORTATION

Contract #: 04-0120F4Cty: SF/ALA Rte: 80 PM: 13.2/13.9File #: 1.28**WELDING INSPECTION REPORT****Resident Engineer:** Pursell, Gary**Address:** 333 Burma Road**City:** Oakland, CA 94607**Report No:** WIR-015960**Date Inspected:** 31-Jul-2010**Project Name:** SAS Superstructure**OSM Arrival Time:** 630**Prime Contractor:** American Bridge/Fluor Enterprises, a JV**OSM Departure Time:** 1500**Contractor:** American Bridge/Fluor Enterprises, a JV**Location:** Jobsite**CWI Name:** See below**CWI Present:** Yes No**Inspected CWI report:** Yes No N/A**Rod Oven in Use:** Yes No N/A**Electrode to specification:** Yes No N/A**Weld Procedures Followed:** Yes No N/A**Qualified Welders:** Yes No N/A**Verified Joint Fit-up:** Yes No N/A**Approved Drawings:** Yes No N/A**Approved WPS:** Yes No N/A**Delayed / Cancelled:** Yes No N/A**Bridge No:** 34-0006**Component:** SAS OBG**Summary of Items Observed:**

- 1). OBG Field Splice 1W/2W Weld ID: D1 & D2, Face A
- 2). OBG Field Splice 1W/2W Weld ID: D1 & D2, Face B
- 3). OBG Field Splice 5W/6W Weld ID: D1 & D2, Face B
- 4). OBG Field Splice 3E/4E Weld ID: D1 & D2, Face B
- 5). OBG Field Splice 4E/5E Weld ID: C1 & C2, Fac

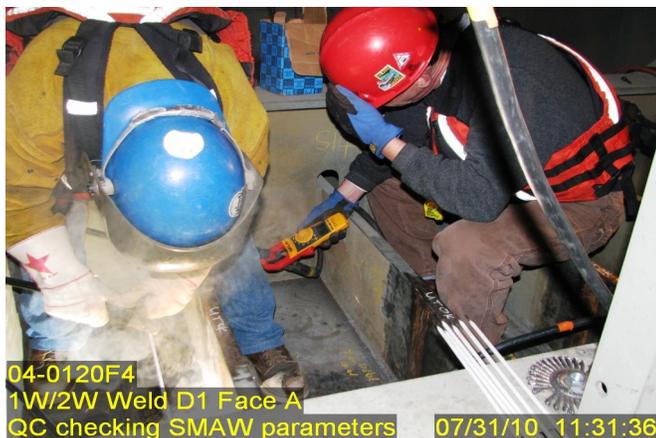
- 1). OBG Field Splice 1W/2W Weld ID: D1 & D2, Face A

The QAI periodically observed AB/F approved welders Xiao Jian Wan (ID 9677) and Jin Pei Wang (ID 7299) grinding to excavate Ultrasonic Testing (UT) reject areas from the A face of OBG Field Splice 1W/2W Weld ID: D1 & D2. The QAI observed welder Xiao Jian Wan (ID 9677) performing Shielded Metal Arc Welding (SMAW) in the 1G (flat) position on a test piece while QC Inspector Tom Pasqualone measured and verified that the welding parameters were within the limits established by the approved welding Procedure Specification (WPS) identified as ABF-WPS-D1.5-1000-Repair. See photo below. No welding was accomplished at this location during the QA Inspectors shift.

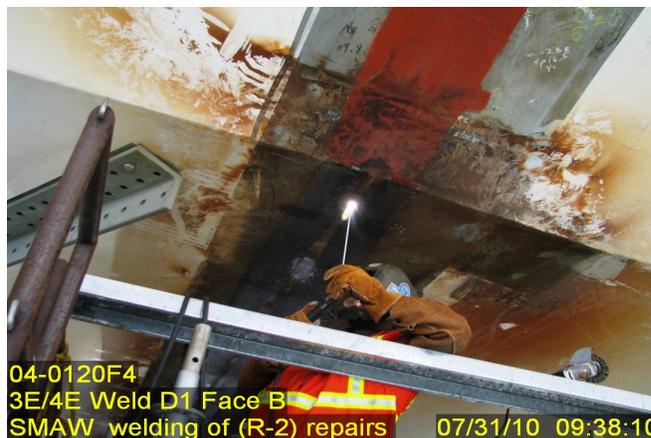
4). OBG Field Splice 3E/4E Weld ID: D1 & D2, Face B

The QAI periodically observed AB/F approved welder Fred Kaddu (ID 2188) performing repair welding per the Shielded Metal Arc Welding (SMAW) process in the 4G (overhead) position of repair cycle 2 (R-2) excavations at Ultrasonic Testing (UT) reject areas from the B face. See photo below. AB/F approved welder Kenneth Chappell was performing the excavating by grinding. AB/F QC Inspector Jesse Cayabyab (who was later replaced by QC Inspector Tony Sherwood) was present to monitor the progress and verify that the welding parameters were within the limits established by the approved welding Procedure Specification (WPS) identified as ABF-WPS-D1.5-1001-Repair. The QAI periodically observed both of the QC Inspectors named above performing Magnetic Particle Testing (MT) of the repair excavations prior to Mr. Kaddu performing welding at the repair locations. The QAI observed that the performance and evaluation of the MT appeared to comply with the MT procedure identified as SE-MT-CT-D1.5-101 Rev. 4. Work was not completed at this location during the QA Inspectors shift and the work appeared to be in general compliance with contract documents.
