**DEPARTMENT OF TRANSPORTATION**

Quality Assurance and Source Inspection

Contract #: 04-0120F4Cty: SF/ALA Rte: 80 PM: 13.2/13.9File #: 1.28**WELDING INSPECTION REPORT****Resident Engineer:** Pursell, Gary**Address:** 333 Burma Road**City:** Oakland, CA 94607**Report No:** WIR-015962**Date Inspected:** 02-Aug-2010**Project Name:** SAS Superstructure**OSM Arrival Time:** 1000**Prime Contractor:** American Bridge/Fluor Enterprises, a JV**OSM Departure Time:** 1830**Contractor:** American Bridge/Fluor Enterprises, a JV**Location:** Job Site**CWI Name:** See Below**CWI Present:** Yes No**Inspected CWI report:** Yes No N/A**Rod Oven in Use:** Yes No N/A**Electrode to specification:** Yes No N/A**Weld Procedures Followed:** Yes No N/A**Qualified Welders:** Yes No N/A**Verified Joint Fit-up:** Yes No N/A**Approved Drawings:** Yes No N/A**Approved WPS:** Yes No N/A**Delayed / Cancelled:** Yes No N/A**Bridge No:** 34-0006**Component:** Orthotropic Box Girders**Summary of Items Observed:**

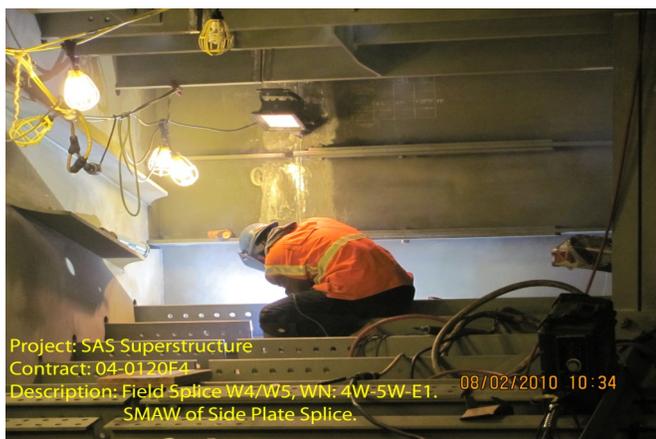
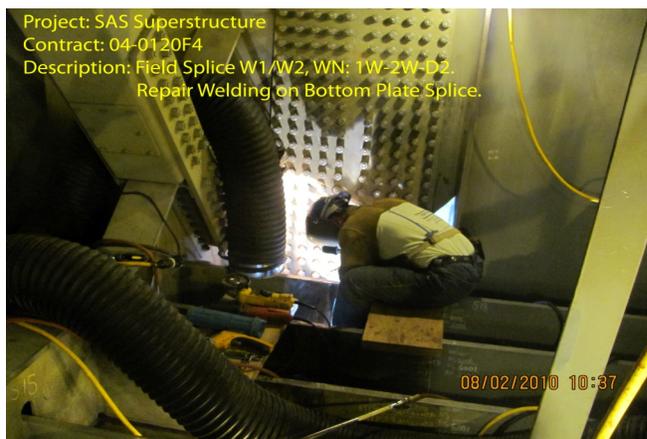
The digital photographs below illustrate the work observed during this scheduled shift.
