**DEPARTMENT OF TRANSPORTATION**

Contract #: 04-0120F4Cty: SF/Ala Rte: 80 PM: 13.2/13.9File #: 69.28**WELDING INSPECTION REPORT****Resident Engineer:** Pursell, Gary**Address:** 333 Burma Road**City:** Oakland, CA 94607**Report No:** WIR-015966**Date Inspected:** 27-Jul-2010**Project Name:** SAS Superstructure**OSM Arrival Time:** 1900**Prime Contractor:** American Bridge/Fluor Enterprises, a JV**OSM Departure Time:** 700**Contractor:** Zhenhua Port Machinery Company, Ltd (ZPMC), Changxing Island **Location:** Shanghai, China**CWI Name:** See below**CWI Present:** Yes No**Inspected CWI report:** Yes No N/A**Rod Oven in Use:** Yes No N/A**Electrode to specification:** Yes No N/A**Weld Procedures Followed:** Yes No N/A**Qualified Welders:** Yes No N/A**Verified Joint Fit-up:** Yes No N/A**Approved Drawings:** Yes No N/A**Approved WPS:** Yes No N/A**Delayed / Cancelled:** Yes No N/A**Bridge No:** 34-0006**Component:** Tower and OBG Components**Summary of Items Observed:**

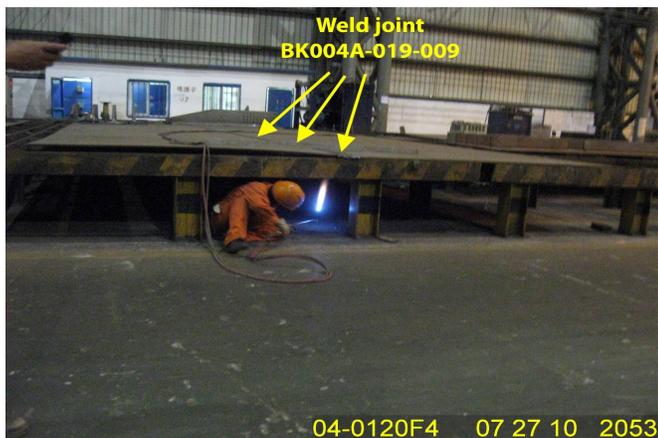
Heat straightening of weld joint BK004A-019-009 located on PCMK OBG bike path plate. QC was identified as ZPMC CWI Qiu Wen (QC1). Assisting QC1 at this location and appearing to be monitoring the welding and recording data was ZPMC QC Xu Jie (QCA1), who was not a CWI. Heat treatment observed by this QA Inspector and recorded by QCA1 appeared to comply with HSR1(B)8919 presented to this QA Inspector by QCA1. See photo below.
