DEPARTMENT OF TRANSPORTATION

Contract #: 04-0120F4Cty: SF/ALA Rte: 80 PM: 13.2/13.9File #: 69.28**WELDING INSPECTION REPORT****Resident Engineer:** Pursell, Gary**Address:** 333 Burma Road**City:** Oakland, CA 94607**Report No:** WIR-015999**Date Inspected:** 27-Jul-2010**Project Name:** SAS Superstructure**OSM Arrival Time:** 700**Prime Contractor:** American Bridge/Fluor Enterprises, a JV**OSM Departure Time:** 1900**Contractor:** Zhenhua Port Machinery Company, Ltd (ZPMC), Changxing Island **Location:** Shanghai, China**CWI Name:** Mr. Xu Le Feng**CWI Present:** Yes No**Inspected CWI report:** Yes No N/A**Rod Oven in Use:** Yes No N/A**Electrode to specification:** Yes No N/A**Weld Procedures Followed:** Yes No N/A**Qualified Welders:** Yes No N/A**Verified Joint Fit-up:** Yes No N/A**Approved Drawings:** Yes No N/A**Approved WPS:** Yes No N/A**Delayed / Cancelled:** Yes No N/A**Bridge No:** 34-0006**Component:** Tower**Summary of Items Observed:**

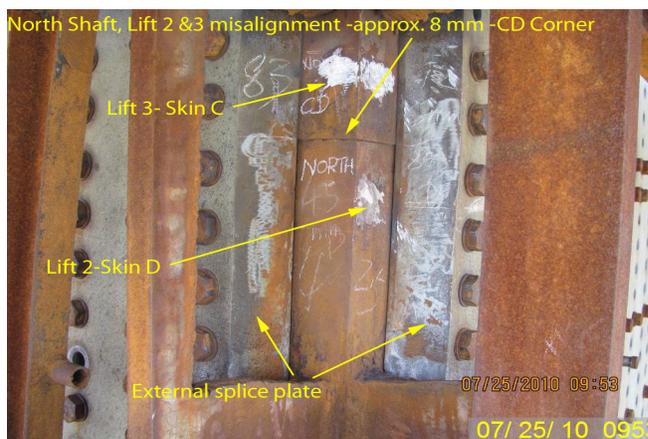
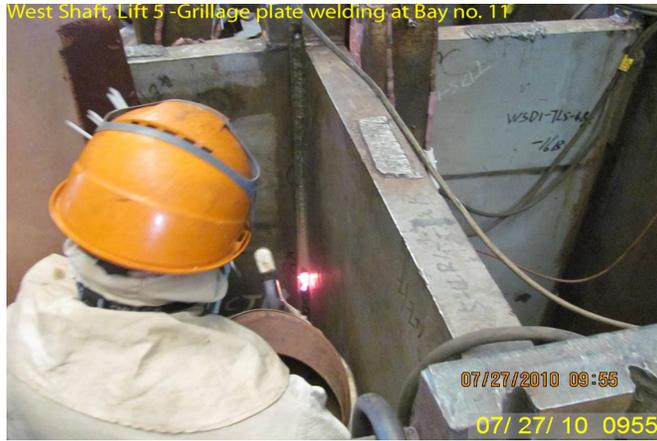
7.This QA inspector, Baskar Govindarajan, wrote an Incident report for the offset of approx. 8 mm observed in North tower, Lift 2 & 3, Skin C, CD corner in 83 mtr. elevation. (Photo attached with this report)
