DEPARTMENT OF TRANSPORTATION

Contract #: 04-0120F4Cty: SF/ALA Rte: 80 PM: 13.2/13.9File #: 1.28**WELDING INSPECTION REPORT****Resident Engineer:** Pursell, Gary**Address:** 333 Burma Road**City:** Oakland, CA 94607**Report No:** WIR-016046**Date Inspected:** 03-Aug-2010**Project Name:** SAS Superstructure**OSM Arrival Time:** 1000**Prime Contractor:** American Bridge/Fluor Enterprises, a JV**OSM Departure Time:** 1830**Contractor:** American Bridge/Fluor Enterprises, a JV**Location:** Job Site**CWI Name:** See Below**CWI Present:** Yes No**Inspected CWI report:** Yes No N/A**Rod Oven in Use:** Yes No N/A**Electrode to specification:** Yes No N/A**Weld Procedures Followed:** Yes No N/A**Qualified Welders:** Yes No N/A**Verified Joint Fit-up:** Yes No N/A**Approved Drawings:** Yes No N/A**Approved WPS:** Yes No N/A**Delayed / Cancelled:** Yes No N/A**Bridge No:** 34-0006**Component:** Orthotropic Box Girders**Summary of Items Observed:**

WELDING INSPECTION REPORT

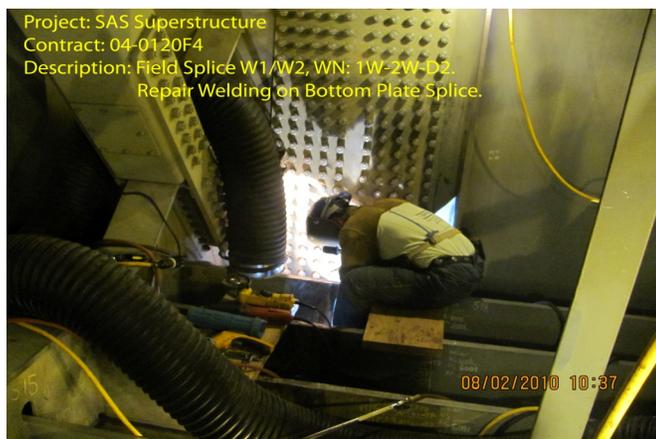
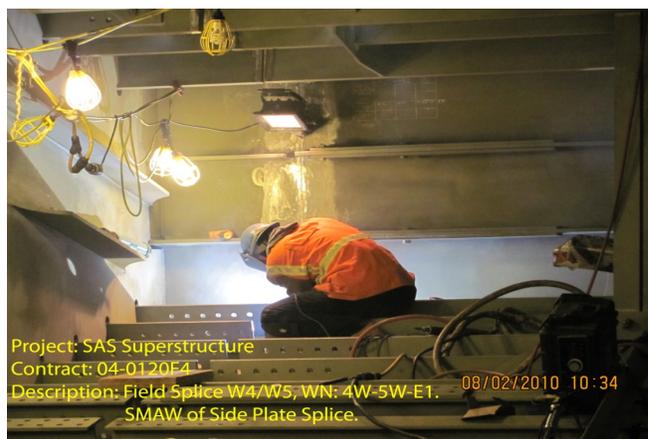
The digital photographs below illustrate the work observed during this scheduled shift.
