DEPARTMENT OF TRANSPORTATION

Contract #: 04-0120F4Cty: SF/ALA Rte: 80 PM: 13.2/13.9File #: 1.28**WELDING INSPECTION REPORT****Resident Engineer:** Pursell, Gary**Address:** 333 Burma Road**City:** Oakland, CA 94607**Report No:** WIR-016075**Date Inspected:** 05-Aug-2010**Project Name:** SAS Superstructure**OSM Arrival Time:** 700**Prime Contractor:** American Bridge/Fluor Enterprises, a JV**OSM Departure Time:** 1530**Contractor:** American Bridge/Fluor Enterprises, a JV**Location:** Jobsite**CWI Name:** See below**CWI Present:** Yes No**Inspected CWI report:** Yes No N/A**Rod Oven in Use:** Yes No N/A**Electrode to specification:** Yes No N/A**Weld Procedures Followed:** Yes No N/A**Qualified Welders:** Yes No N/A**Verified Joint Fit-up:** Yes No N/A**Approved Drawings:** Yes No N/A**Approved WPS:** Yes No N/A**Delayed / Cancelled:** Yes No N/A**Bridge No:** 34-0006**Component:** SAS OBG**Summary of Items Observed:**

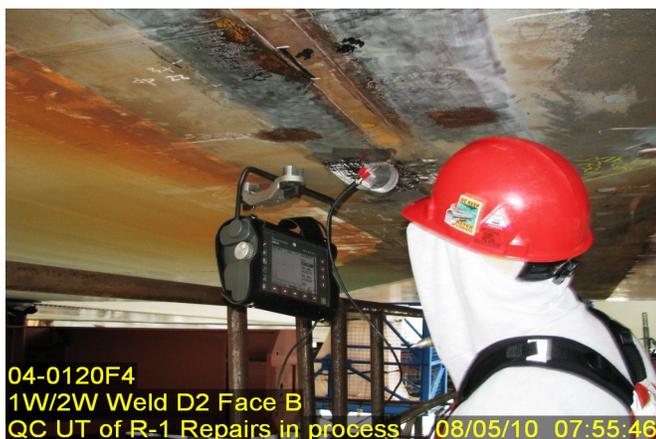
- 1). OBG Field Splice 1W/2W Weld ID: D1 & D2, Face B

The QAI periodically observed Quality Control (QC) Inspector Tom Pasqualone performing Ultrasonic Testing (UT) of repair cycle 1 (R-1) UT repairs from the B Face of OBG Field Splice 1W/2W Weld ID: D1 and D2. The QAI observed Mr. Pasqualone utilized the UT Procedure identified as SE-UT-D1.5-CT-100 Rev.4 during the examination of the splice weld. The QC technician performed the required shear wave testing during the testing for weld soundness utilizing a .63 x .75 rectangular transducer. The QAI observed that The QC Inspector had marked some areas that appeared to be UT rejects. See Summary of Conversations. The UT examination was completed from face A during the QA Inspectors shift and the work at this location appeared to be in general compliance with contract documents. See photo below of QC UT in process.

At the completion of the UT from face B at this location the QA Inspector asked how many areas had been rejected. The QC Inspector stated that 9 or 10 areas were class A rejects from the B face of OBG Field Splice 1W/2W Weld ID: D1 & D2.
