DEPARTMENT OF TRANSPORTATION

Quality Assurance and Source Inspection

WELDING INSPECTION REPORT

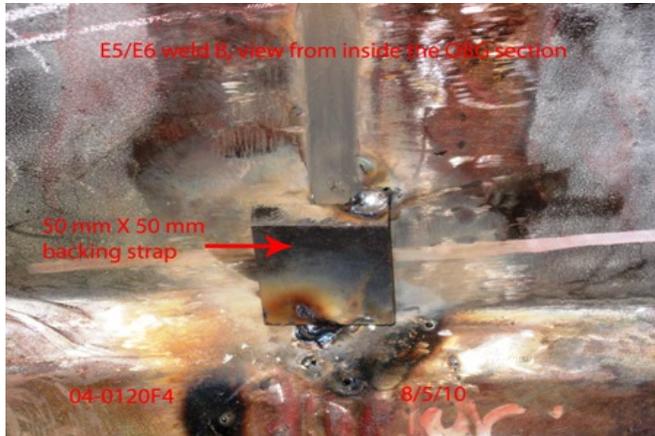
At weld joint E5/E6 – B, inside the OBG section this QA Inspector observed ABF welding personnel Jin Pei Wang (# 7299) setting up to remove the backing strap on the bottom section of the weld using the carbon arc process. See photo below of backing strap used on the inside of the weld joint to facilitate welding from the outside to complete the weld. QC Inspector Steve McConnell was present.
