**DEPARTMENT OF TRANSPORTATION**

Contract #: 04-0120F4Cty: SF/ALA Rte: 80 PM: 13.2/13.9File #: 1.28**WELDING INSPECTION REPORT****Resident Engineer:** Pursell, Gary**Address:** 333 Burma Road**City:** Oakland, CA 94607**Report No:** WIR-016110**Date Inspected:** 06-Aug-2010**Project Name:** SAS Superstructure**OSM Arrival Time:** 1000**Prime Contractor:** American Bridge/Fluor Enterprises, a JV**OSM Departure Time:** 1830**Contractor:** American Bridge/Fluor Enterprises, a JV**Location:** Job Site**CWI Name:** See Below**CWI Present:** Yes No**Inspected CWI report:** Yes No N/A**Rod Oven in Use:** Yes No N/A**Electrode to specification:** Yes No N/A**Weld Procedures Followed:** Yes No N/A**Qualified Welders:** Yes No N/A**Verified Joint Fit-up:** Yes No N/A**Approved Drawings:** Yes No N/A**Approved WPS:** Yes No N/A**Delayed / Cancelled:** Yes No N/A**Bridge No:** 34-0006**Component:** Orthotropic Box Girders**Summary of Items Observed:**

## WELDING INSPECTION REPORT

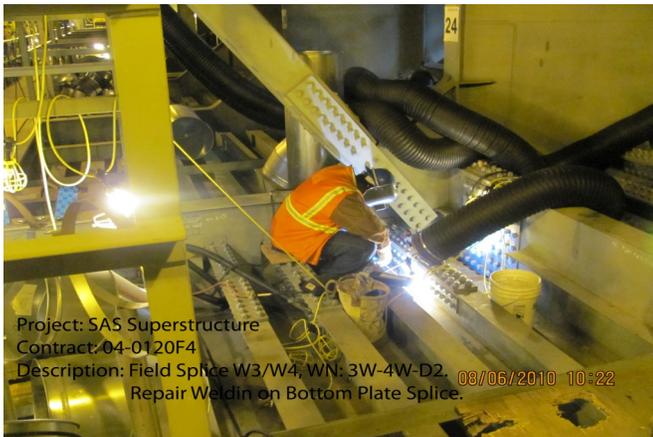
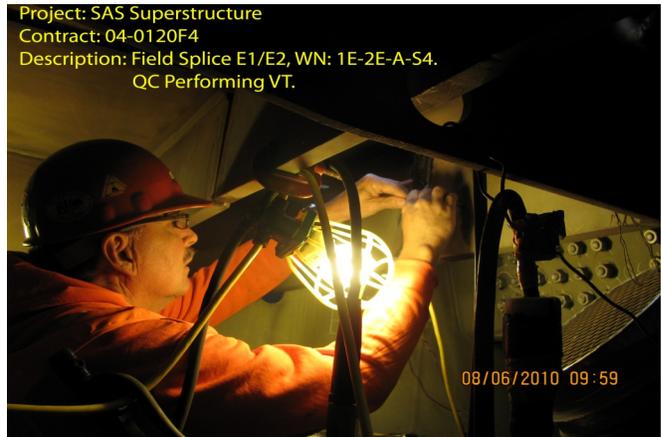
The digital photographs below illustrate the work observed during this scheduled shift.
