**DEPARTMENT OF TRANSPORTATION**

Contract #: 04-0120F4Cty: SF/ALA Rte: 80 PM: 13.2/13.9File #: 1.28**WELDING INSPECTION REPORT****Resident Engineer:** Pursell, Gary**Address:** 333 Burma Road**City:** Oakland, CA 94607**Report No:** WIR-016113**Date Inspected:** 09-Aug-2010**Project Name:** SAS Superstructure**OSM Arrival Time:** 630**Prime Contractor:** American Bridge/Fluor Enterprises, a JV**OSM Departure Time:** 1500**Contractor:** American Bridge/Fluor Enterprises, a JV**Location:** Job Site**CWI Name:** See below**CWI Present:** Yes No**Inspected CWI report:** Yes No N/A**Rod Oven in Use:** Yes No N/A**Electrode to specification:** Yes No N/A**Weld Procedures Followed:** Yes No N/A**Qualified Welders:** Yes No N/A**Verified Joint Fit-up:** Yes No N/A**Approved Drawings:** Yes No N/A**Approved WPS:** Yes No N/A**Delayed / Cancelled:** Yes No N/A**Bridge No:** 34-0006**Component:** SAS OBG**Summary of Items Observed:**

# WELDING INSPECTION REPORT

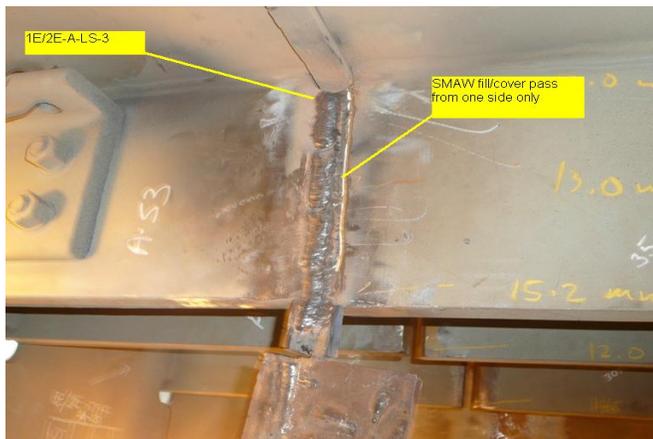
1E/2E-A-S5

Upon the arrival of the QA Inspector at the above identified location, the QA Inspector randomly observed the ABF welder Xiao Jian Wan preparing to begin the SMAW fill passes. The QA Inspector noted the SMAW root pass was complete upon the arrival of the QA Inspector. The QA Inspector noted the weld was not maintained at 200°F as per the Caltrans Special Provisions "Field Welding" note "C". The QA Inspector randomly observed the ABF welder preheat the material to 200°F utilizing a rosebud torch. The QA Inspector noted the SE QC Inspector John Pagliero was on site monitoring the in process preheats and welding parameters of approved welding procedure identified as ABF-WPS-D1.5-1012-3. The QA Inspector randomly observed the ABF welder remove the E9018 1/8" electrodes from the rod container at 0745. The QA Inspector randomly observed the ABF welder begin the SMAW fill pass on the above identified weld joint. The QA Inspector noted the SMAW parameters were 125 amps and appeared to be in general compliance with the above identified WPS. The QA Inspector noted the ABF welder continued the fill pass through out the duration of the QA Inspectors shift.
