DEPARTMENT OF TRANSPORTATION

Contract #: 04-0120F4Cty: SF/ALA Rte: 80 PM: 13.2/13.9File #: 69.28**WELDING INSPECTION REPORT****Resident Engineer:** Pursell, Gary**Address:** 333 Burma Road**City:** Oakland, CA 94607**Report No:** WIR-016125**Date Inspected:** 28-Jul-2010**Project Name:** SAS Superstructure**OSM Arrival Time:** 1900**Prime Contractor:** American Bridge/Fluor Enterprises, a JV**OSM Departure Time:** 700**Contractor:** Zhenhua Port Machinery Company, Ltd (ZPMC), Changxing Island **Location:** Shanghai, China**CWI Name:** See Below**CWI Present:** Yes No**Inspected CWI report:** Yes No N/A**Rod Oven in Use:** Yes No N/A**Electrode to specification:** Yes No N/A**Weld Procedures Followed:** Yes No N/A**Qualified Welders:** Yes No N/A**Verified Joint Fit-up:** Yes No N/A**Approved Drawings:** Yes No N/A**Approved WPS:** Yes No N/A**Delayed / Cancelled:** Yes No N/A**Bridge No:** 34-0006**Component:** OBG**Summary of Items Observed:**

OBG Segment Trial Assembly

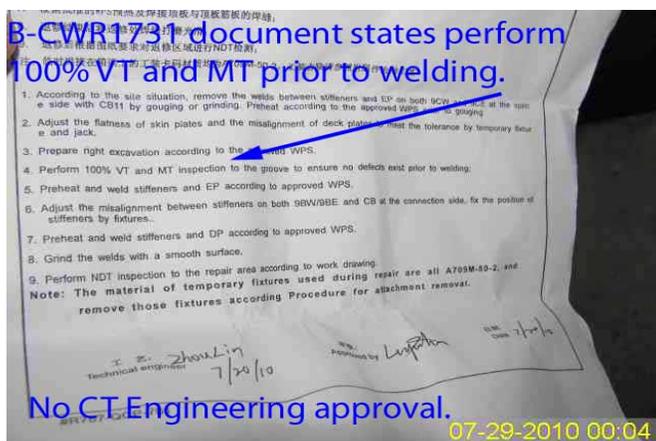
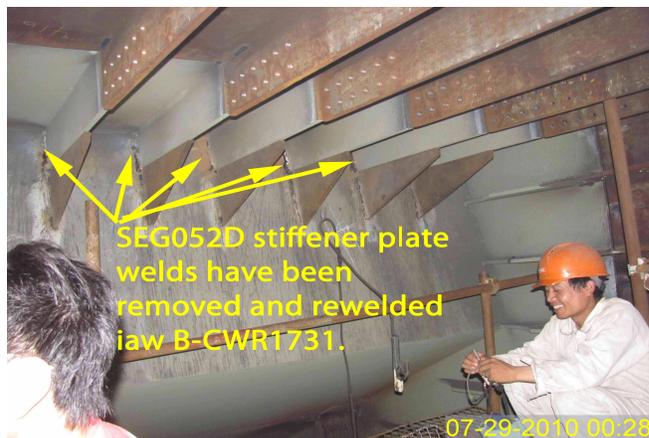
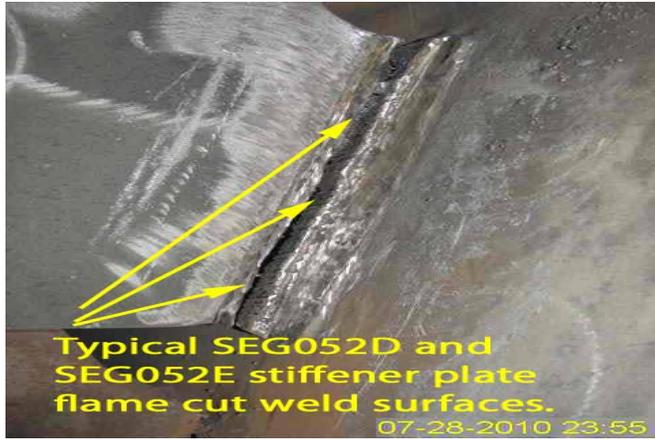
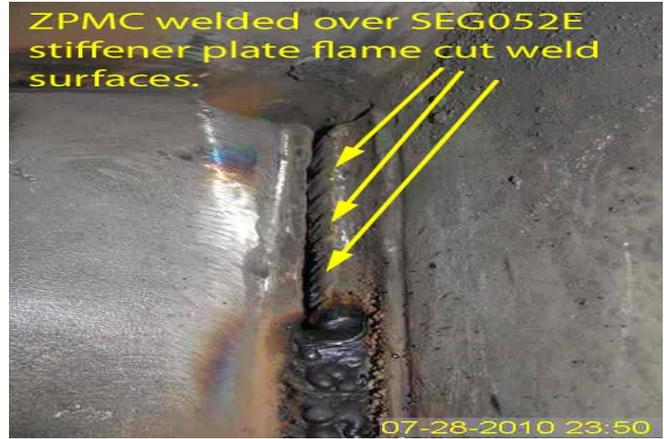
This QA Inspector performed random in process observations of the trial assembly of OBG cross beam 11 and this Quality Assurance (QA) Inspector discovered the following issues:

- ZPMC personnel have removed deck panel stiffener component SEG052D and E Stiffener plate welds in a manner inconsistent with the repair procedure QC presented to this QA Inspector.

- The repair procedure is a Critical Weld Repair (CWR) procedure identified as B-CWR1731. This procedure has not been approved by the Engineer.
- ZPMC personnel have used acetylene/oxygen torches to remove OBG deck panel stiffeners from the edge panel of segment 9BW. CWR B-CWR1731 states the welds will be removed using Gouging or Grinding methods.

- ZPMC did not actually remove the welds, instead, they cut the end of the stiffeners approximately 10mm to 15mm away from the weld attaching it to the edge panel. This method of removal creates the need for a CJP weld adjacent to and parallel to the original weld. This additional weld joint is not detailed on the approved shop drawings.

- The stiffeners are identified as X8E.
- Additionally, ZPMC performed welding over the flame cut surfaces prior to grinding the joint preparation to a smooth, bright surface as specified in AWS D1.5 2002.

- ZPMC has not documented completion of visual or magnetic particle inspections of the weld grooves prior to welding as required by CWR B-CWR1731.
