DEPARTMENT OF TRANSPORTATION

Contract #: 04-0120F4Cty: SF/ALA Rte: 80 PM: 13.2/13.9File #: 69.28**WELDING INSPECTION REPORT****Resident Engineer:** Pursell, Gary**Address:** 333 Burma Road**City:** Oakland, CA 94607**Report No:** WIR-016128**Date Inspected:** 31-Jul-2010**Project Name:** SAS Superstructure**OSM Arrival Time:** 1900**Prime Contractor:** American Bridge/Fluor Enterprises, a JV**OSM Departure Time:** 700**Contractor:** Zhenhua Port Machinery Company, Ltd (ZPMC), Changxing Island **Location:** Shanghai, China**CWI Name:** See Below**CWI Present:** Yes No**Inspected CWI report:** Yes No N/A**Rod Oven in Use:** Yes No N/A**Electrode to specification:** Yes No N/A**Weld Procedures Followed:** Yes No N/A**Qualified Welders:** Yes No N/A**Verified Joint Fit-up:** Yes No N/A**Approved Drawings:** Yes No N/A**Approved WPS:** Yes No N/A**Delayed / Cancelled:** Yes No N/A**Bridge No:** 34-0006**Component:** OBG**Summary of Items Observed:**

OBG Segment Trial Assembly

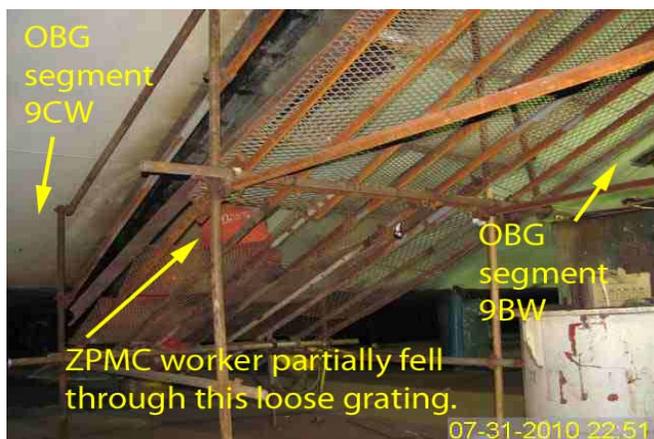
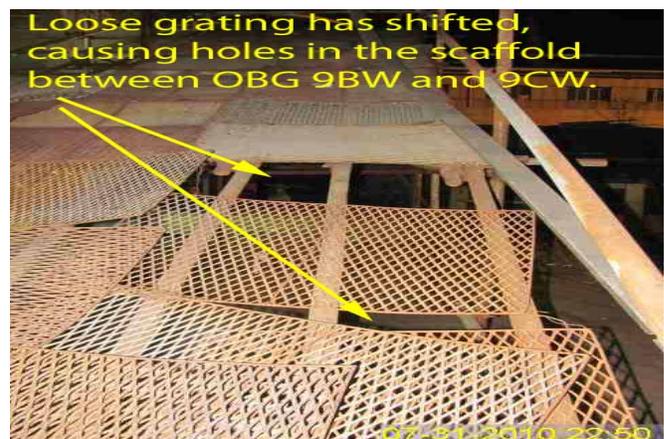
This QA Inspector observed segment 9BW to 9CW counterweight side has an angled scaffold that is located approximately six feet below the butt weld joining these two segments and at approximately 2250 hours one ZPMC worker was walking up scaffold as he moved equipment toward the counterweight side of the OBG. This worker stepped through an opening in the grating and his leg fell through the hole. He was able to pull his leg out of the opening and he did not appear to have been injured by the fall. This QA Inspector observed several of the grating sections do not appear to have been secured to the scaffold support frame. Below are two photographs showing gaps in the grating.
