**DEPARTMENT OF TRANSPORTATION**

Contract #: 04-0120F4Cty: SF/ALA Rte: 80 PM: 13.2/13.9File #: 1.28**WELDING INSPECTION REPORT****Resident Engineer:** Pursell, Gary**Address:** 333 Burma Road**City:** Oakland, CA 94607**Report No:** WIR-016137**Date Inspected:** 10-Aug-2010**Project Name:** SAS Superstructure**OSM Arrival Time:** 1000**Prime Contractor:** American Bridge/Fluor Enterprises, a JV**OSM Departure Time:** 1830**Contractor:** American Bridge/Fluor Enterprises, a JV**Location:** Job Site

# WELDING INSPECTION REPORT

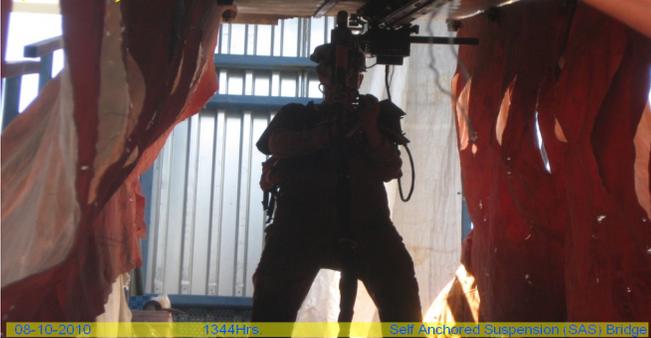
At OBG 5E/6E side plate 'E' outside, ABF welder Bryce Howell was noted prepping his Esab plasma arc machine and lining up his Bug-o track to perform gouging on the backing bar removal of the splice butt joint.

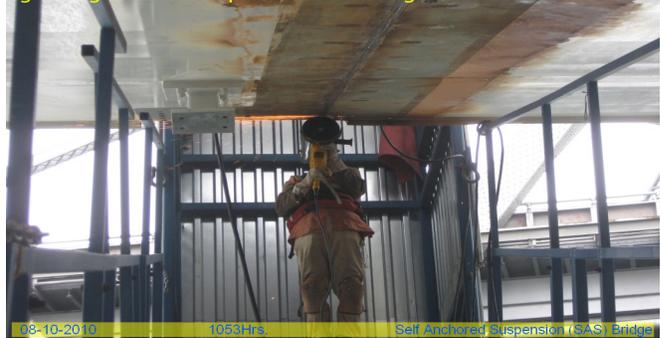
At OBG 4E/5E side plate 'C' outside, ABF personnel was noted flush grinding the weld cover reinforcement of the splice butt joint as required. The personnel was using a 9 inch angle grinder with the grinding cut oriented parallel to the bridge direction.

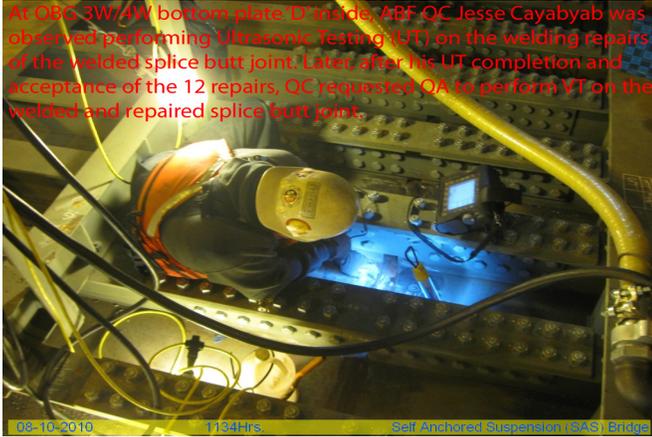
At 3W/4W bottom plate 'D' inside, QA observed ABF QC Jesse Cayabyab perform Ultrasonic Testing (UT) on the welding repairs of the splice butt joint. The QC inspector performed UT on 12 repair areas and after his acceptance and completion of the butt joint, QC requested this QA to perform visual test (VT) on the completely welded and repaired butt joint. This QA accommodated to the request and performed the VT. During VT, QA measured the weld cover reinforcement and checked the surface profile of any irregularities. It was noted that the weld cover reinforcement and the surface profile were free from significant defects and deemed in compliance to the code requirements.

At CMC 3W/4W bottom plate T7 inside ABF QC Jesse Cayabyab was observed performing Ultrasonic Testing (UT) on the welding repairs of the welded splice butt joint. Later after his UT completion and acceptance of the 12 repairs, QC requested QA to perform VT on the welded and repaired splice butt joint.
