DEPARTMENT OF TRANSPORTATION

Contract #: 04-0120F4Cty: SF/ALA Rte: 80 PM: 13.2/13.9File #: 1.28**WELDING INSPECTION REPORT****Resident Engineer:** Pursell, Gary**Address:** 333 Burma Road**City:** Oakland, CA 94607**Report No:** WIR-016158**Date Inspected:** 10-Aug-2010**Project Name:** SAS Superstructure**OSM Arrival Time:** 1000**Prime Contractor:** American Bridge/Fluor Enterprises, a JV**OSM Departure Time:** 1830**Contractor:** American Bridge/Fluor Enterprises, a JV**Location:** Job Site**CWI Name:** See Below**CWI Present:** Yes No**Inspected CWI report:** Yes No N/A**Rod Oven in Use:** Yes No N/A**Electrode to specification:** Yes No N/A**Weld Procedures Followed:** Yes No N/A**Qualified Welders:** Yes No N/A**Verified Joint Fit-up:** Yes No N/A**Approved Drawings:** Yes No N/A**Approved WPS:** Yes No N/A**Delayed / Cancelled:** Yes No N/A**Bridge No:** 34-0006**Component:** Orthotropic Box Girders**Summary of Items Observed:**

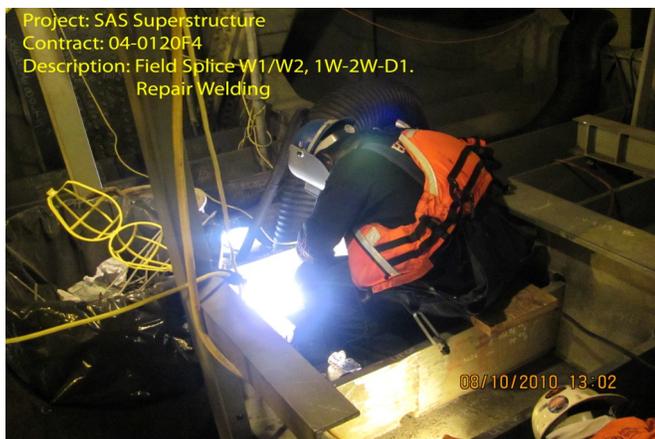
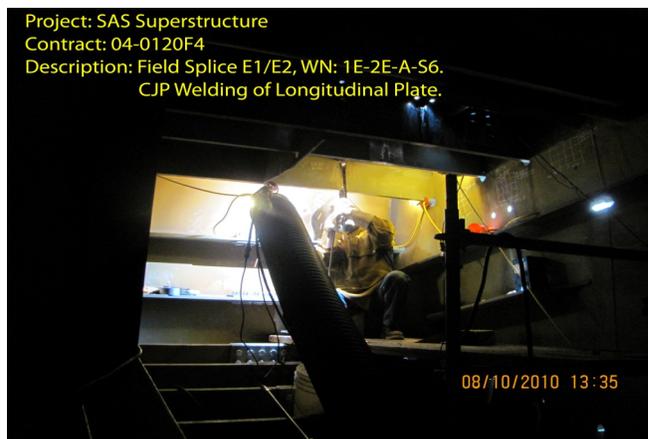
The digital photographs below illustrate the work observed during this scheduled shift.
