**DEPARTMENT OF TRANSPORTATION**

Contract #: 04-0120F4Cty: SF/ALA Rte: 80 PM: 13.2/13.9File #: 1.28**WELDING INSPECTION REPORT****Resident Engineer:** Pursell, Gary**Address:** 333 Burma Road**City:** Oakland, CA 94607**Report No:** WIR-016160**Date Inspected:** 11-Aug-2010**Project Name:** SAS Superstructure**OSM Arrival Time:** 1000**Prime Contractor:** American Bridge/Fluor Enterprises, a JV**OSM Departure Time:** 1830**Contractor:** American Bridge/Fluor Enterprises, a JV**Location:** Job Site**CWI Name:** See Below**CWI Present:** Yes No**Inspected CWI report:** Yes No N/A**Rod Oven in Use:** Yes No N/A**Electrode to specification:** Yes No N/A**Weld Procedures Followed:** Yes No N/A**Qualified Welders:** Yes No N/A**Verified Joint Fit-up:** Yes No N/A**Approved Drawings:** Yes No N/A**Approved WPS:** Yes No N/A**Delayed / Cancelled:** Yes No N/A**Bridge No:** 34-0006**Component:** Orthotropic Box Girders**Summary of Items Observed:**

## WELDING INSPECTION REPORT

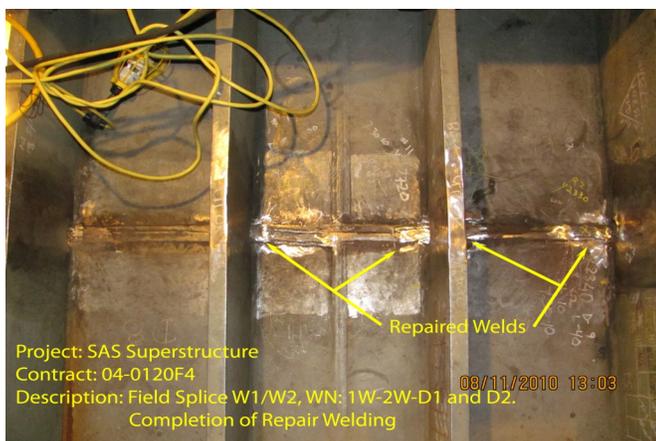
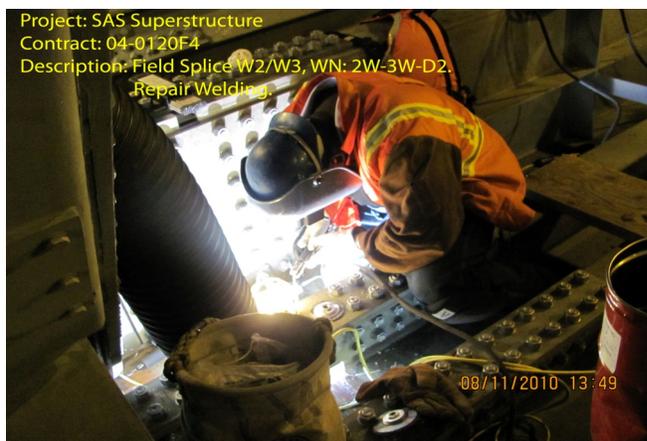
The digital photographs below illustrate the work observed during this scheduled shift.
