DEPARTMENT OF TRANSPORTATION

Contract #: 04-0120F4Cty: SF/ALA Rte: 80 PM: 13.2/13.9File #: 1.28**WELDING INSPECTION REPORT****Resident Engineer:** Pursell, Gary**Address:** 333 Burma Road**City:** Oakland, CA 94607**Report No:** WIR-016164**Date Inspected:** 12-Aug-2010**Project Name:** SAS Superstructure**OSM Arrival Time:** 1000**Prime Contractor:** American Bridge/Fluor Enterprises, a JV**OSM Departure Time:** 1830**Contractor:** American Bridge/Fluor Enterprises, a JV**Location:** Job Site**CWI Name:** See Below**CWI Present:** Yes No**Inspected CWI report:** Yes No N/A**Rod Oven in Use:** Yes No N/A**Electrode to specification:** Yes No N/A**Weld Procedures Followed:** Yes No N/A**Qualified Welders:** Yes No N/A**Verified Joint Fit-up:** Yes No N/A**Approved Drawings:** Yes No N/A**Approved WPS:** Yes No N/A**Delayed / Cancelled:** Yes No N/A**Bridge No:** 34-0006**Component:** Orthotropic Box Girders**Summary of Items Observed:**

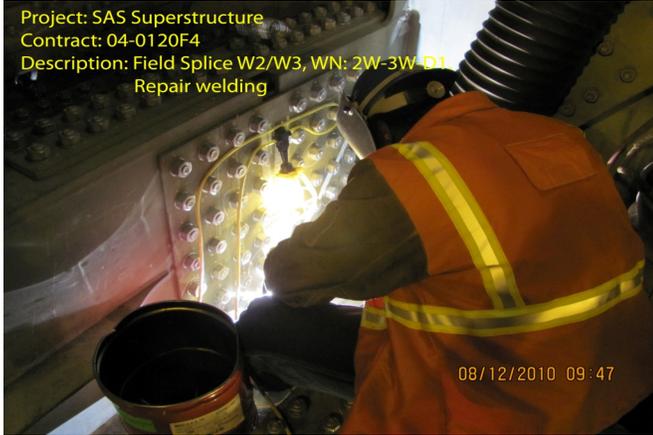
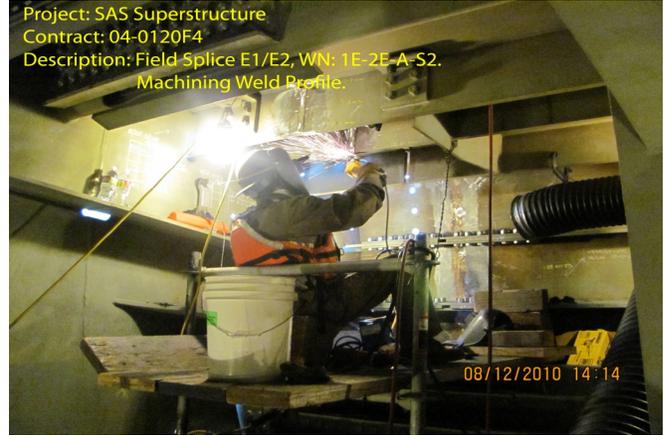
The digital photographs below illustrate the work observed during this scheduled shift.
