**DEPARTMENT OF TRANSPORTATION**

Contract #: 04-0120F4Cty: SF/ALA Rte: 80 PM: 13.2/13.9File #: 1.28**WELDING INSPECTION REPORT****Resident Engineer:** Pursell, Gary**Address:** 333 Burma Road**City:** Oakland, CA 94607**Report No:** WIR-016214**Date Inspected:** 13-Aug-2010**Project Name:** SAS Superstructure**OSM Arrival Time:** 1000**Prime Contractor:** American Bridge/Fluor Enterprises, a JV**OSM Departure Time:** 1730**Contractor:** American Bridge/Fluor Enterprises, a JV**Location:** Job Site**CWI Name:** See Below**CWI Present:** Yes No**Inspected CWI report:** Yes No N/A**Rod Oven in Use:** Yes No N/A**Electrode to specification:** Yes No N/A**Weld Procedures Followed:** Yes No N/A**Qualified Welders:** Yes No N/A**Verified Joint Fit-up:** Yes No N/A**Approved Drawings:** Yes No N/A**Approved WPS:** Yes No N/A**Delayed / Cancelled:** Yes No N/A**Bridge No:** 34-0006**Component:** Orthotropic Box Girders**Summary of Items Observed:**

## WELDING INSPECTION REPORT

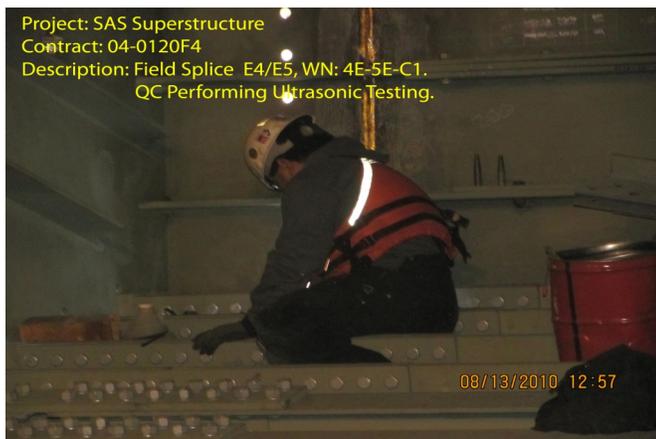
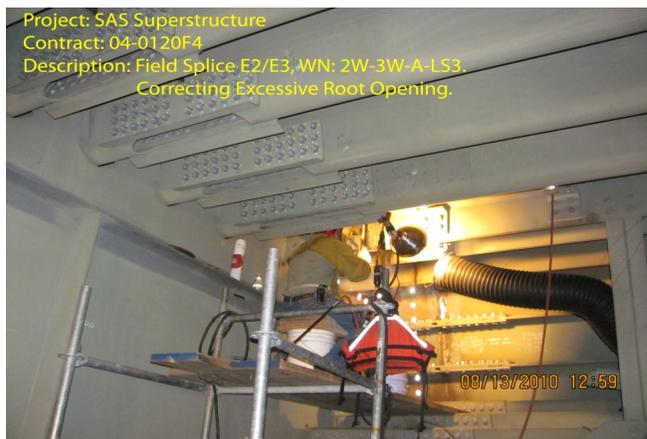
The digital photographs below illustrate the work observed during this scheduled shift.
