**DEPARTMENT OF TRANSPORTATION**

Contract #: 04-0120F4Cty: SF/ALA Rte: 80 PM: 13.2/13.9File #: 1.28**WELDING INSPECTION REPORT****Resident Engineer:** Pursell, Gary**Address:** 333 Burma Road**City:** Oakland, CA 94607**Report No:** WIR-016243**Date Inspected:** 12-Aug-2010**Project Name:** SAS Superstructure**OSM Arrival Time:** 630**Prime Contractor:** American Bridge/Fluor Enterprises, a JV**OSM Departure Time:** 1500**Contractor:** American Bridge/Fluor Enterprises, a JV**Location:** Job Site**CWI Name:** See below**CWI Present:** Yes No**Inspected CWI report:** Yes No N/A**Rod Oven in Use:** Yes No N/A**Electrode to specification:** Yes No N/A**Weld Procedures Followed:** Yes No N/A**Qualified Welders:** Yes No N/A**Verified Joint Fit-up:** Yes No N/A**Approved Drawings:** Yes No N/A**Approved WPS:** Yes No N/A**Delayed / Cancelled:** Yes No N/A**Bridge No:** 34-0006**Component:** SAS OBG**Summary of Items Observed:**

## WELDING INSPECTION REPORT

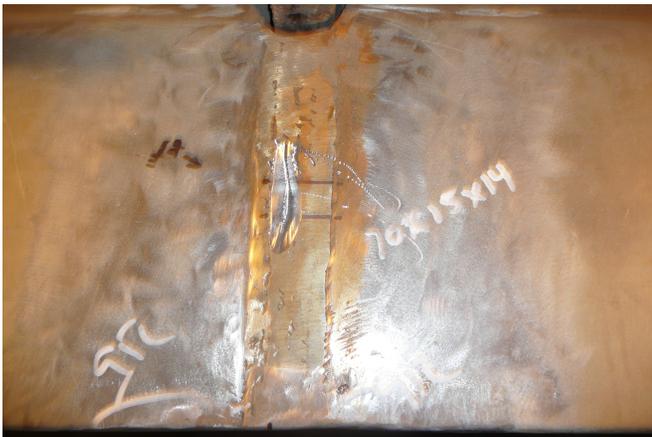
1E/2E-A-S5

Upon the arrival of the QA Inspector at the above identified location, it was observed the weld joint was previously completed. The QA Inspector observed the SE QC Inspector had previously performed ultrasonic testing and located a rejectable indication. The QA Inspector observed the ABF welder Xiao Jian Wan had excavated the rejectable indication utilizing a burr bit grinder. The QA Inspector performed dimensional measurements of excavation and noted they were 70mm x 15mm x 14mm deep. QA Inspector randomly observed no welding was performed on excavated weld joint on the QA Inspectors shift. The QA Inspector spoke with the SE QC Inspector Steve McConnell regarding the UT (see summary of conversations).
