DEPARTMENT OF TRANSPORTATION

Contract #: 04-0120F4Cty: SF/ALA Rte: 80 PM: 13.2/13.9File #: 1.28**WELDING INSPECTION REPORT****Resident Engineer:** Pursell, Gary**Address:** 333 Burma Road**City:** Oakland, CA 94607**Report No:** WIR-016249**Date Inspected:** 17-Aug-2010**Project Name:** SAS Superstructure**OSM Arrival Time:** 1000**Prime Contractor:** American Bridge/Fluor Enterprises, a JV**OSM Departure Time:** 1830**Contractor:** American Bridge/Fluor Enterprises, a JV**Location:** Job Site

WELDING INSPECTION REPORT

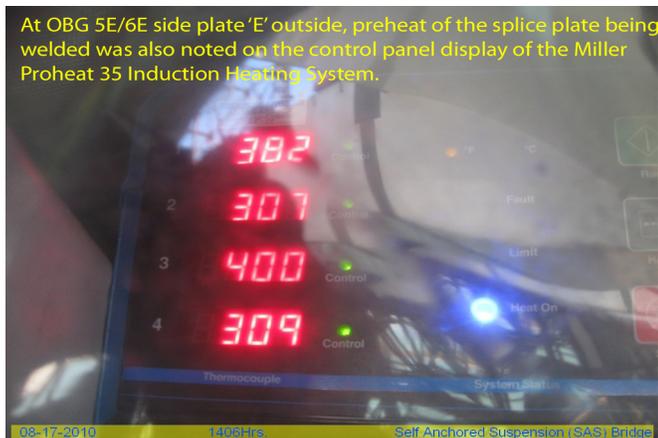
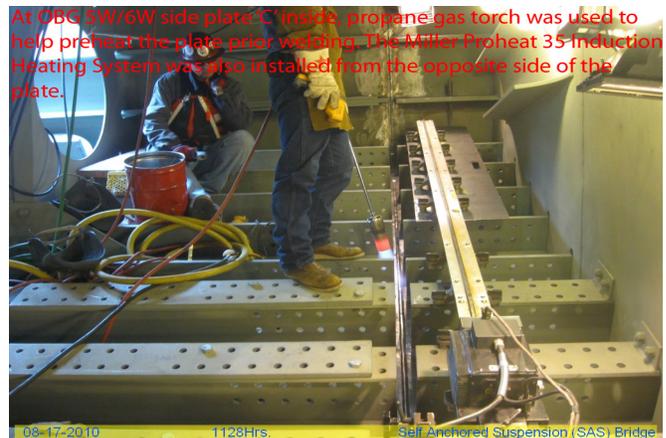
At OBG 5W/6W side plate 'C' (1000mm to 3200mm) inside, QA randomly observed ABF/JV qualified welder Sungtao, Huang ID # 3794 perform CJP groove (splice) welding root pass on the splice butt joint. The welder was observed performing automatic welding in the 3G (vertical) position utilizing a dual shield Flux Cored Arc Welding (FCAW-G) with E71T-1M, 1/16" diameter wire electrode and implementing Caltrans approved Welding Procedure Specification (WPS) ABF-WPS-D15-3042B-1. The joint being welded had a single V-groove butt joint with backing bar. The splice joint was preheated and maintained to greater than 150 degrees Fahrenheit using Miller Proheat 35 Induction Heating System located at the opposite side of the plate prior/during welding. ABF Quality Control (QC) William Sherwood was noted monitoring the welding parameters of the welder. At the end of the shift, fill pass welding was still continuing and should remain tomorrow.

QA randomly observed ABF/JV qualified welders Rory Hogan and Jeremy Dolman continuing to perform CJP groove (splice) back welding fill pass on Orthotropic Box Girder (OBG) 5E/6E side plate 'E1' outside. The welder was observed back welding in the 4G (overhead) position utilizing a dual shield Flux Cored Arc Welding (FCAW-G) with E71T-1M, 1/16" diameter wire electrode and implementing Caltrans approved Welding Procedure Specification (WPS) ABF-WPS-D15-3110-4. The welder was using a track mounted welder holder assembly that was remotely controlled. The joint being welded has the backing bar gouged using the Esab Plasma Arc machine and was ground smooth. The gouged and ground splice butt joint was also Non Destructive Testing

(NDT) tested using the Magnetic Particle Testing (MT). The splice joint was preheated and maintained to greater than 150 degrees Fahrenheit using Miller Proheat 35 Induction Heating System located on top of the plate prior welding and by moving the blanket to the side of the weld being welded during welding. The vicinity was also properly protected from wind and other climatic conditions. ABF Quality Control (QC) Jim Cunningham was noted monitoring the welding parameters of the welder. During the shift, fill pass welding was still continuing and should remain tomorrow.

At OBG 5E/6E side plate 'C' outside, ABF personnel was noted flush grinding the weld cover reinforcement of the welded splice butt joint as required. The personnel was using 4" disc grinder with the grinding cut to the plate parallel to the direction of the bridge in compliance to the project specification.

At OBG 4W/5W side plate 'C' outside, QA randomly observed ABF personnel Mike Maday and Bryce Howell perform plasma arc gouging on the backing bar removal of the splice butt joint. The personnel were using an Esab plasma arc gouging machine that has the nozzle holder attached to a Bug-o track. Gouging of the backing bar was not completed today and should continue tomorrow.

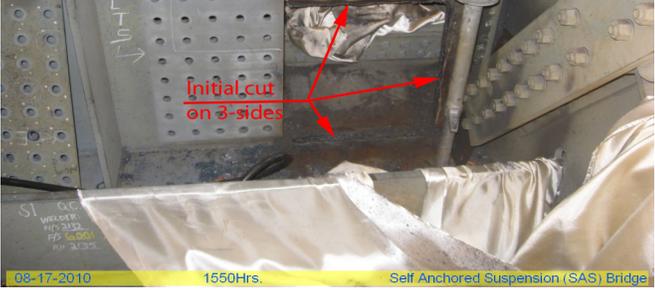
At OBG 1W/2W line W3 panel point 13 inside, the plate that was replaced due to damage during shipment from ZPMC, China and splice welded into the longitudinal connection plate but failed the Ultrasonic Testing (UT) is now being cut and to be replaced. The plate was previously repaired thru American Bridge Fluor/Joint Venture (ABF/JV) NCR-002 dated March 17, 2010. According to ABF QC William Sherwood, ABF is awaiting the approved Request for Information (RFI) for the exact dimension of the plate to be cut. According to ABF welder Fred Kaddu, the plate was initially cut 2 inches away to the anticipated cutting lines of the plate.

At O&G 1W/2W line W3 panel point 13, the original plate had been cut out and the replacement plate had been welded/spliced into the longitudinal connection plate and rejected by Ultrasonic Testing (UT) is now being cut using oxy-acetylene cutting torch. Per QC William Sherwood, ABF is awaiting the approved RFI prior to cut the final dimension.
