DEPARTMENT OF TRANSPORTATION

Contract #: 04-0120F4Cty: SF/ALA Rte: 80 PM: 13.2/13.9File #: 74.28**WELDING INSPECTION REPORT****Resident Engineer:** Pursell, Gary**Address:** 333 Burma Road**City:** Oakland, CA 94607**Report No:** WIR-016250**Date Inspected:** 16-Aug-2010**Project Name:** SAS Superstructure**OSM Arrival Time:** 730**Prime Contractor:** American Bridge/Fluor Enterprises, a JV**OSM Departure Time:** 1300**Contractor:** Goodwin Steel, UK**Location:** Trentham, UK**CWI Name:****CWI Present:**

Bridge No: 34-0006**Component:** Cable Band**Summary of Items Observed:**

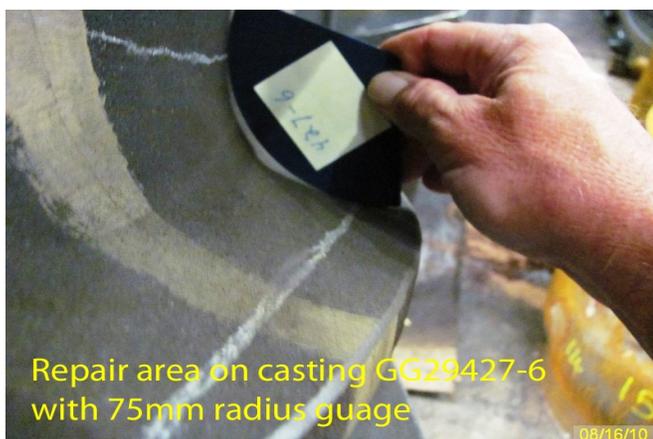
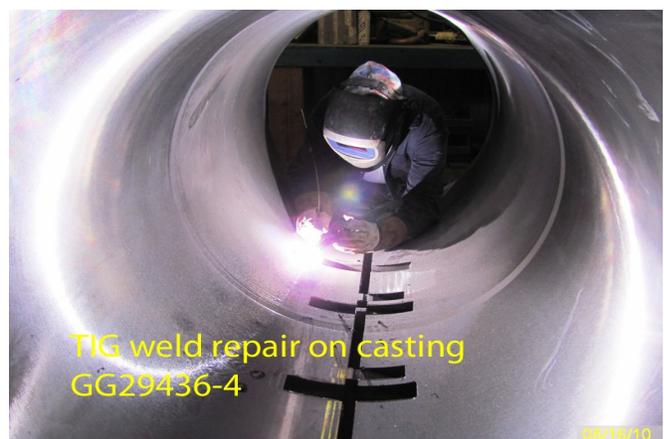
The QA inspector observed Goodwin International welding personnel William Whyte perform welding of 14 excavations on casting GG29436-4, B9-1-M Revision 2. The repair plan was submitted to the QA on August 13, 2010 for verbal approval. The repair welding utilized the gas shielded tungsten arc weld (GTAW) process per the welding procedure specification WPS 271 Rev 1 in the 1G (flat) position. The filler metal utilized was identified as 2.4mm diameter CMW 1940. The minimum preheat temperature of 20 degrees Celsius was verified to meet the WPS requirements by the QA inspector utilizing a Tempilstik temperature indicator. The GTAW welding average amperage of 160, voltage of 12.3 and travel speed of 100mm/min was verified to be within the WPS parameter range by the QA inspector. The work was completed on this date and appears to meet the minimum requirements of the welding procedure specification. See pictures below.
