DEPARTMENT OF TRANSPORTATION

Contract #: 04-0120F4Cty: SF/ALA Rte: 80 PM: 13.2/13.9File #: 99.28**WELDING INSPECTION REPORT****Resident Engineer:** Pursell, Gary**Address:** 333 Burma Road**City:** Oakland, CA 94607**Report No:** WIR-016253**Date Inspected:** 16-Aug-2010**Project Name:** SAS Superstructure**OSM Arrival Time:** 700**Prime Contractor:** American Bridge/Fluor Enterprises, a JV**OSM Departure Time:** 1900**Contractor:** Zhenhua Port Machinery Company, Ltd (ZPMC)**Location:** Shanghai, China

Orthotropic Box Girder (OBG) Trial Assembly Areas

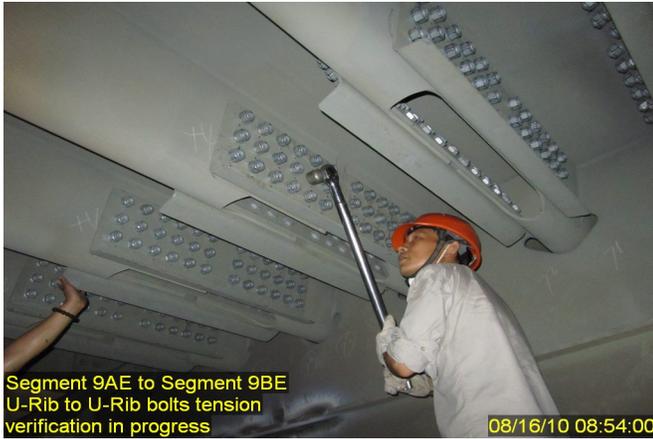
This QA Inspector witnessed the final bolt tension verification on bolts connecting the U-Rib to U-Rib at the transverse splice between Panel Points (PP) 73 and PP 74 for Segment 9AE to Segment 9BE. The QA Inspector verified the bolt tension on a random basis and the results appeared to be in general compliance. The Inspection was performed against Notification No. 00454 dated August 16, 2010.

Segment 9AE to Segment 9BE
U-Rib to U-Rib bolts tension
verification in progress
08/16/10 08:54:00

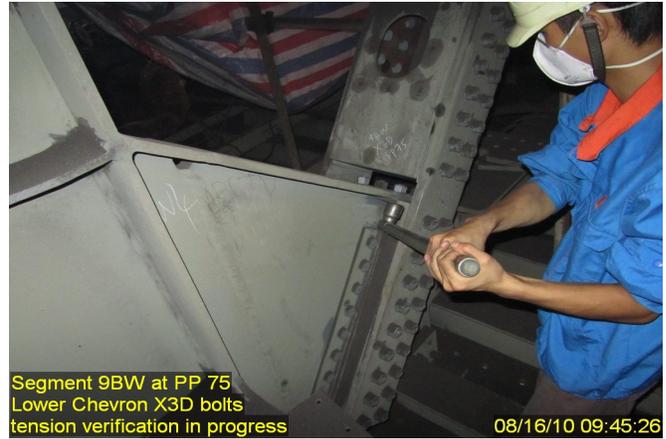
This Quality Assurance (QA) Inspector witnessed final bolt tension verification for Lower Chevron X3D Bracket connected to floor beam flange and to the splice plate at Panel Point (PP) 74, PP 75 and PP 76 for Segment 9BW at Cross Beam and Counter Weight side. Inspected 10% on a random basis and found the tension to be in general compliance. Inspection was performed against the Notification No. 00454 Dated August 16, 2010.

Segment 9BW at PP 75
Lower Chevron X3D bolts
tension verification in progress
08/16/10 09:45:26

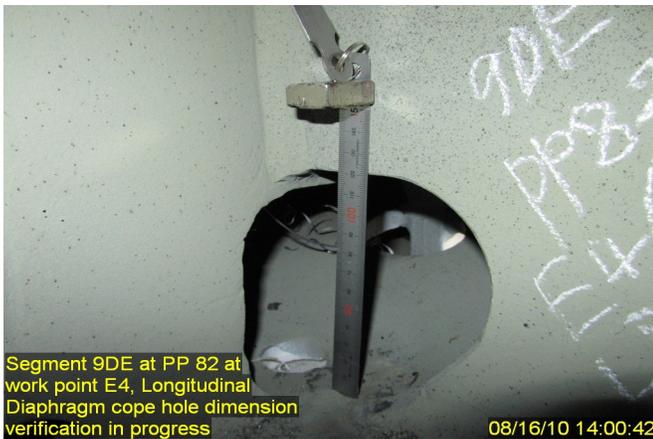
The Cope hole dimensions located at the Floor Beam to Bottom Panel, Floor Beam to Side Panel and at Longitudinal Diaphragms were verified and measured at the Panel Points (PP) 82 at the Cross Beam (CB) and Bike Path (BK) side. The QA Inspector measured the cope hole dimensions using a 150mm steel ruler.

Segment 9DE at PP 82 at
work point E4, Longitudinal
Diaphragm cope hole dimension
verification in progress
08/16/10 14:00:42

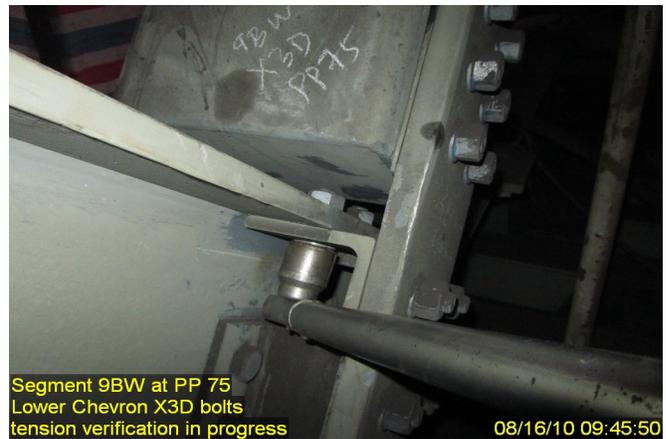
Segment 9BW at PP 75
Lower Chevron X3D bolts
tension verification in progress
08/16/10 09:45:50

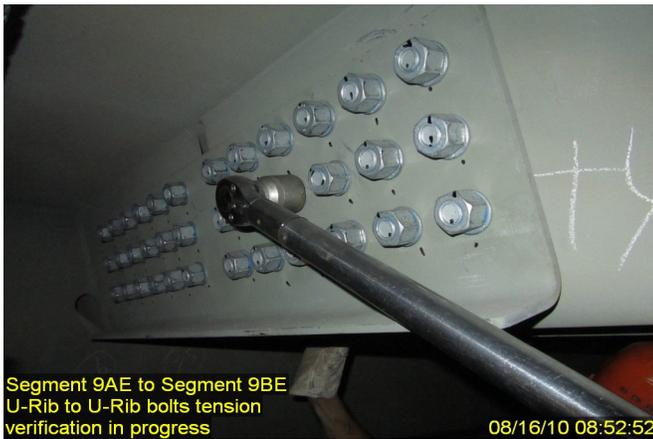
Segment 9AE to Segment 9BE
U-Rib to U-Rib bolts tension
verification in progress
08/16/10 08:52:52

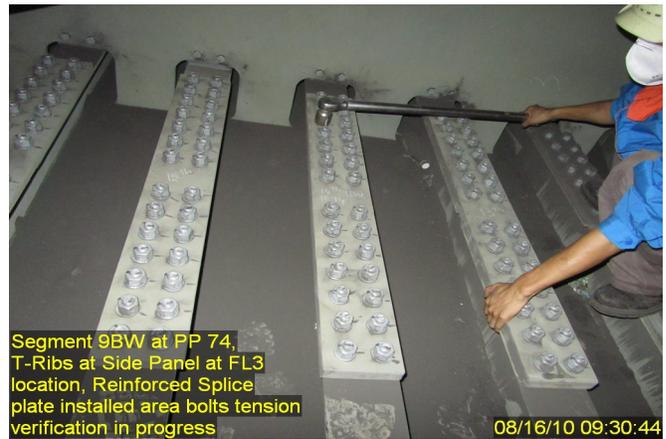
This QA Inspector witnessed the final bolt tension verification on bolts connecting the T-Ribs to T-Ribs at Side Panel Cross Beam side at reinforced splice plates installed area at Panel Points (PP) 74, PP 75 and PP 76 for Segment 9DW. The QA Inspector verified the bolt tension on a random basis and the results appeared to be in general compliance. The Inspection was performed against Notification No. 00439 dated July 25, 2010. The reinforced splice plates are installed at following locations.

Segment 9BW at PP 74,
T-Ribs at Side Panel at FL3
location, Reinforced Splice
plate installed area bolts tension
verification in progress
08/16/10 09:30:44
